Draft Preliminary Engineering Report

Drinking Water System Improvements

Lake Shastina Community Services District

December 2023

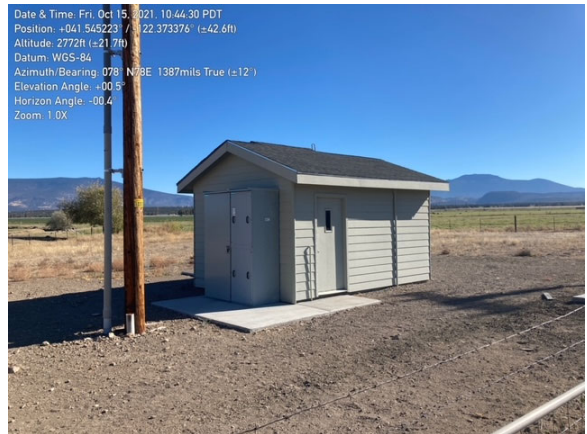
Photograph 3.1 Well #4 Well House

Well 4 (Photograph 3.1) is the highest producing well, at 1,350 gallons per minute (gpm), and is the most important to the system. If this well ceases to function, especially during the summer months, customers could be forced to conserve, or be completely without water service. The consequences depend on where the customer is in the system, how much storage is available when the well goes down, and how long the well is offline. Figure 3-3 shows a piping schematic for this well.

Well 4 has a grade elevation of 2,760 feet above sea level and has a 200 horsepower (hp) pump to withdraw the water from the underground aquifer. The average water level is roughly 80 feet below ground surface. This well has the capability of connecting to the LSCSD’s mobile generator, but there is no permanent electrical backup supply. Overall, this well is in operable condition having undergone mechanical repairs and electrical motor upgrades after an unplanned shutdown. However, with this being the most important well to the system, it is imperative to have a redundant/backup well in case Well 4 ever needs to be taken offline for service, especially during the summer months.

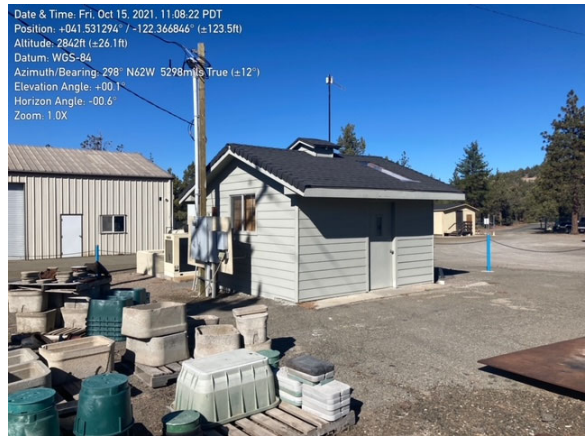
Photograph 3.2 Well #3 Well House

Well 3 (Photograph 3.2), which is the second most important well within the production system and is the primary winter well, produces an average of 850 gpm. Well 3 is situated 2,840 feet above sea level and is located centrally within the system, at the LSCSD maintenance yard (location shown in Figure 3-1). Well 3 has a 150-hp vertical motor that pumps the water located from 80 feet below ground. This well has a permanent generator in case of emergency. Overall, this well is in operable condition having undergone mechanical repairs and electrical motor upgrades after being shut down due to mechanical issues. Well 3 does not have adequate yield to meet summer water needs if Well 4 were to go offline. Figure 3-4 shows a piping schematic.

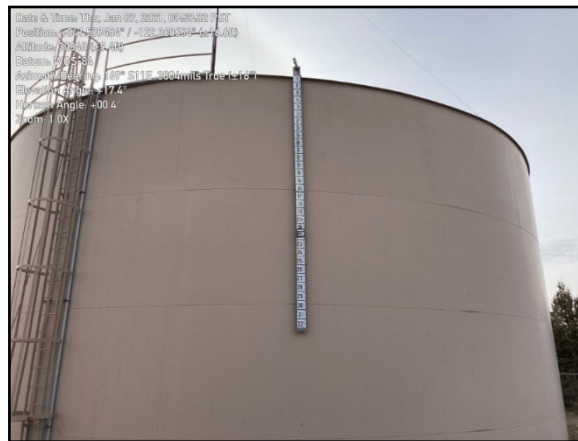
Photograph 3.4 Juniper Tank (Tank 1) showing manual tank level gauge.

- The interior coating is at the end of its service life as evidenced by significant blistering and corrosion.
- Sediment depth is ¼ inch inside the tank.
- Entry hatch gasket is not sealing and has corrosion on the underside of the lid.
- The exterior coating has minor rust spots on the roof, ladder, and handrails and corrosion in low spots on the roof.
- The exterior shell is in good condition.

- Sandblast and recoat the interior coating.
- Replace the entry hatch gasket.
- Touch up the exterior coating.

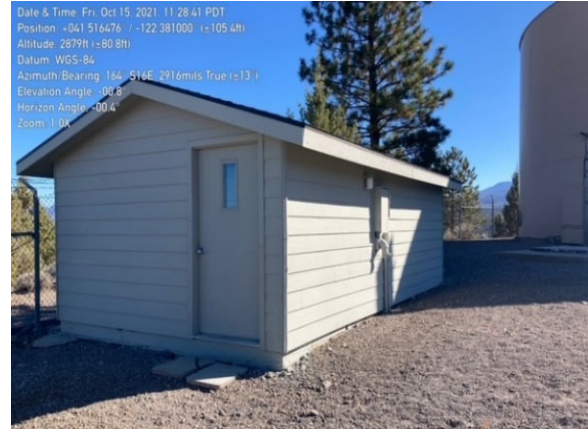
Photograph 3.9 Booster Pump Station B-51

Booster Pump Station B-51 (Photograph 3.9) is located adjacent to Tank 2 and provides a local pressure zone where the homes surrounding the tank are at approximately the same elevation as Tank 2. The location is shown on Figure 3-1 and the piping schematic is shown on Figure 3-15. This pump station consists of two 45-gpm pony pumps, one 250-gpm pump, and three 75-gallon pressure tanks. This pump station is in fair condition.

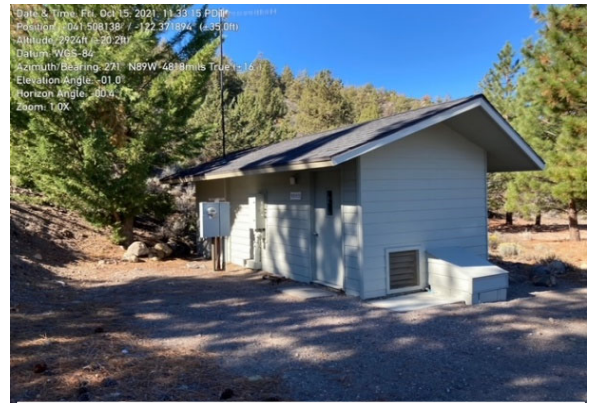
Photograph 3.11 Booster Station B-53

The pump station consists of two pumps with VFDs in parallel, a 20-hp 250-gpm pump and a 50-hp, 500-gpm pump. Operational information is described in Section 3.4.7. This pump station is in good condition.

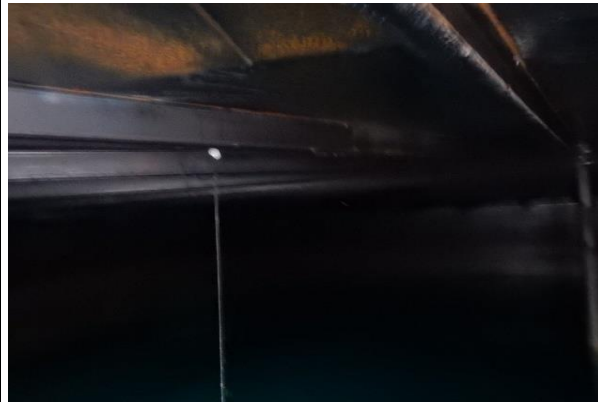
Conclusion/Discrepancies: Surface corrosion covers the plates, minor corrosion on the trusses and hardware. Coating is at the end of its service life and needs redone

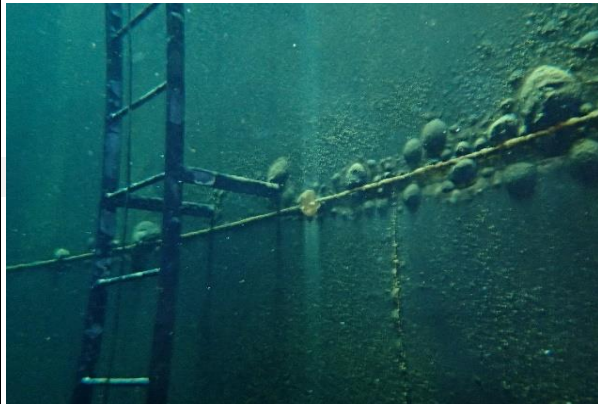
Conclusion/Discrepancies: Weld seams are heavily blistered with corrosion present above the water line corrosion and cracking more extensive

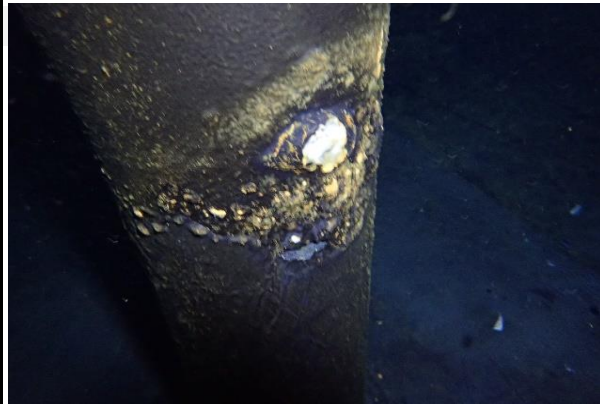
Coating				
Satisfactory	Y	<input type="checkbox"/>	N	<input checked="" type="checkbox"/>
Blistering	Y	<input checked="" type="checkbox"/>	N	<input type="checkbox"/>
Cracking	Y	<input checked="" type="checkbox"/>	N	<input type="checkbox"/>
Peeling	Y	<input type="checkbox"/>	N	<input checked="" type="checkbox"/>
Holidays	Y	<input type="checkbox"/>	N	<input checked="" type="checkbox"/>
Pitting	Y	<input type="checkbox"/>	N	<input checked="" type="checkbox"/>
Corrosion	10%	Y	<input checked="" type="checkbox"/>	N
Seams/Welds	Fair			
Floor/Base Plates	Fair			
Construction	Coated steel			
Conclusion/Discrepancies:	Blistering and surface corrosion noted from exposed steel. Coating has failed sandblast and recoat

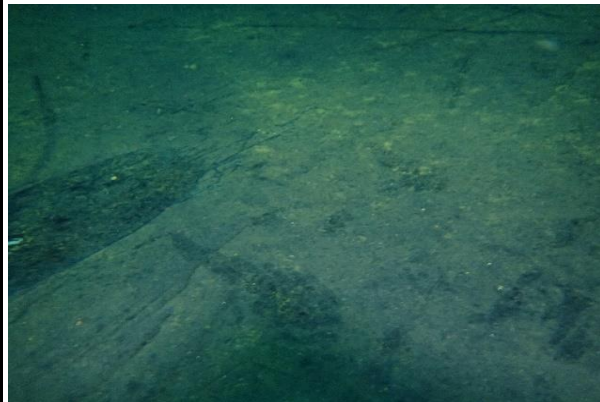
Coating				
Satisfactory	Fair	<input checked="" type="checkbox"/>	N	<input type="checkbox"/>
Blistering	Y	<input checked="" type="checkbox"/>	N	<input type="checkbox"/>
Cracking	Y	<input type="checkbox"/>	N	<input checked="" type="checkbox"/>
Peeling	Y	<input type="checkbox"/>	N	<input checked="" type="checkbox"/>
Holidays	Y	<input type="checkbox"/>	N	<input checked="" type="checkbox"/>
Pitting	Y	<input type="checkbox"/>	N	<input checked="" type="checkbox"/>
Corrosion	3%	Y	<input checked="" type="checkbox"/>	N
Seams/Welds	Fair			
Conclusion/Discrepancies:	Majority if the coating is in good shape with no major discrepancies A few sporadic spots of corrosion / bare steel			
Sediment Depth	1/4 of an inch

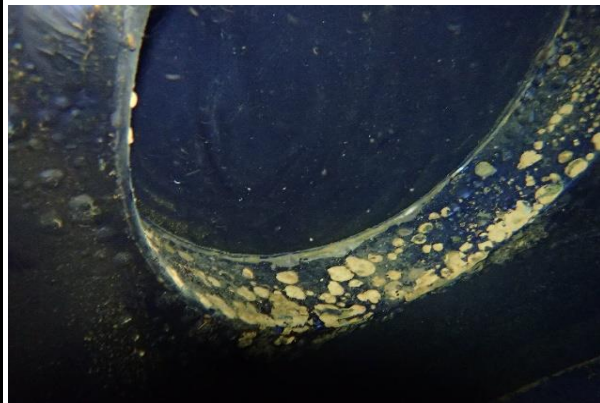
Coating				
Satisfactory	Y	<input type="checkbox"/>	N	<input checked="" type="checkbox"/>
Blistering	Y	<input checked="" type="checkbox"/>	N	<input type="checkbox"/>
Cracking	Y	<input type="checkbox"/>	N	<input checked="" type="checkbox"/>
Peeling	Y	<input type="checkbox"/>	N	<input checked="" type="checkbox"/>
Holidays	Y	<input type="checkbox"/>	N	<input checked="" type="checkbox"/>
Pitting	Y	<input type="checkbox"/>	N	<input checked="" type="checkbox"/>
Corrosion	10%	Y	<input checked="" type="checkbox"/>	N
Seams/Welds	Fair			
Conclusion/Discrepancies:	Blistering and surface corrosion noted around the outer edges and interior of the doorway extension

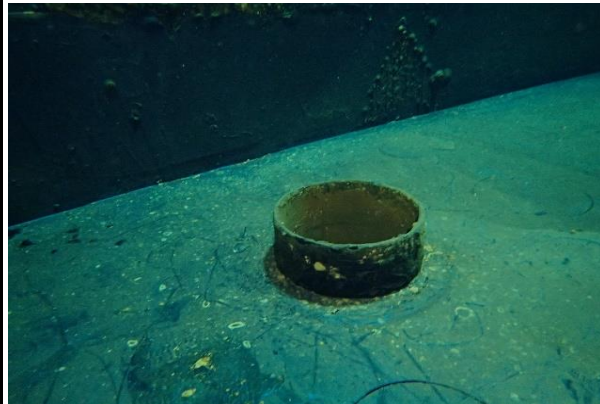
Conclusion/Discrepancies: Blistering and corrosion noted around the top edge of the pipe

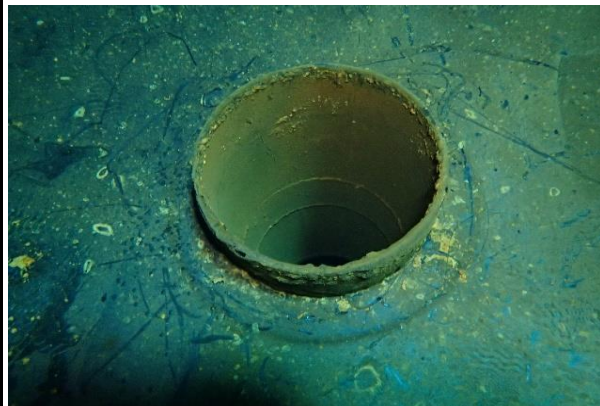
Conclusion/Discrepancies: Blistering and corrosion noted around the weld seam

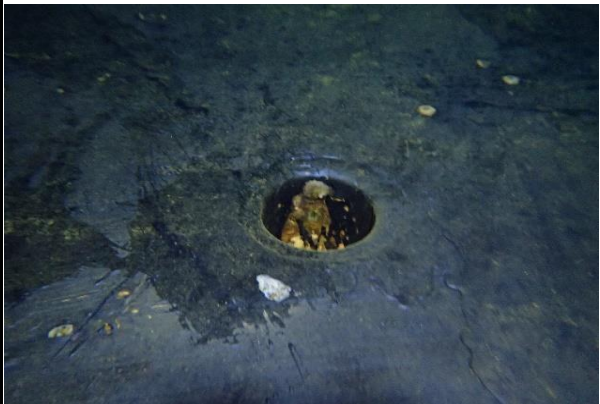
Conclusion/Discrepancies: Corrosion on the interior of the pipe. Welds and coating are intact and in good condition

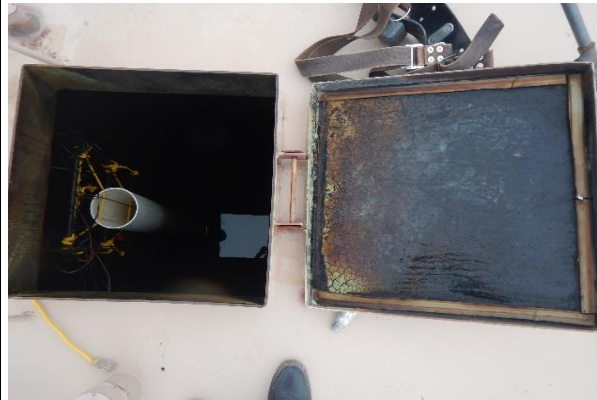
Conclusion/Discrepancies Three sides have gasket in place, minor corrosion on the underside of the lid

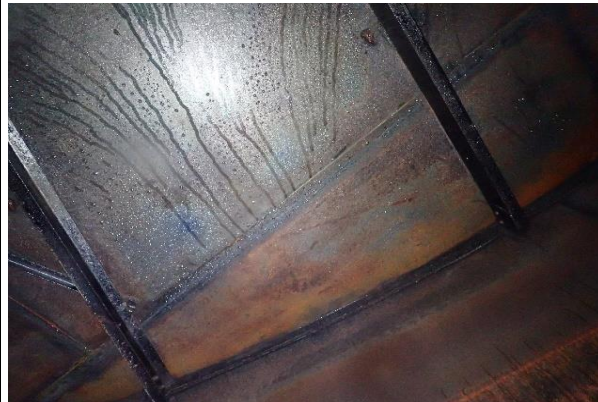
Roof Hatch	Good			
Conclusion/Discrepancies: More corrosion than typically found or expected.				
Corrosion forms due to the high humidity.

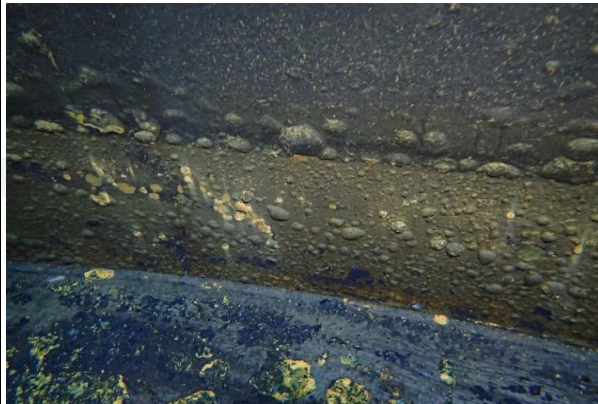
Coating				
Satisfactory	Y	<input type="checkbox"/>	N	<input checked="" type="checkbox"/>
Blistering	Y	<input checked="" type="checkbox"/>	N	<input type="checkbox"/>
Cracking	Y	<input checked="" type="checkbox"/>	N	<input type="checkbox"/>
Peeling	Y	<input checked="" type="checkbox"/>	N	<input type="checkbox"/>
Holidays	Y	<input type="checkbox"/>	N	<input checked="" type="checkbox"/>
Pitting	Y	<input type="checkbox"/>	N	<input checked="" type="checkbox"/>
Corrosion	20% Y	<input checked="" type="checkbox"/>	N	<input type="checkbox"/>
Seams/Welds	Poor			
Rings				
Chime	Poor			
2nd Weld Ring	Poor			
3rd Weld Ring	Poor			
4th Weld Ring	Poor			
5th Weld Ring				
Ring(s)	4 in all	Poor-fair		
Wall to Roof Seam	Fair			
Baffle/Support Walls	None			
Conclusion/Discrepancies: Coating is severely				
blistered, numerous areas of bare steel; corrosion has begun, no pitting currently present

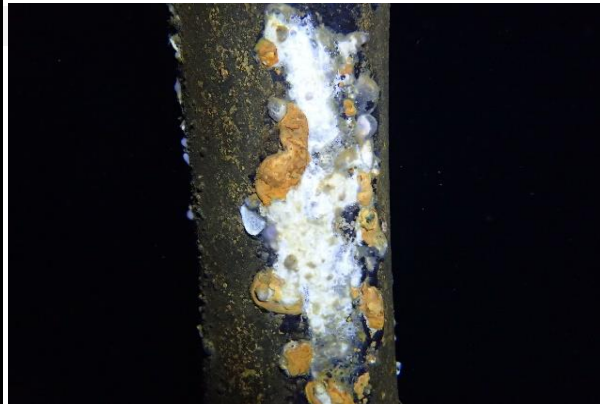
Coating				
Satisfactory	Y	<input type="checkbox"/>	N	<input checked="" type="checkbox"/>
Blistering	Y	<input checked="" type="checkbox"/>	N	<input type="checkbox"/>
Cracking	Y	<input type="checkbox"/>	N	<input checked="" type="checkbox"/>
Peeling	Y	<input type="checkbox"/>	N	<input checked="" type="checkbox"/>
Holidays	Y	<input type="checkbox"/>	N	<input checked="" type="checkbox"/>
Pitting	Y	<input checked="" type="checkbox"/>	N	<input type="checkbox"/>
Corrosion	15%	Y	<input checked="" type="checkbox"/>	N
Seams/Welds	Fair			
Floor/Base Plates	Fair			
Construction	Coated steel			
Conclusion/Discrepancies:	Coating has failed			
corrosion is present with slight pitting

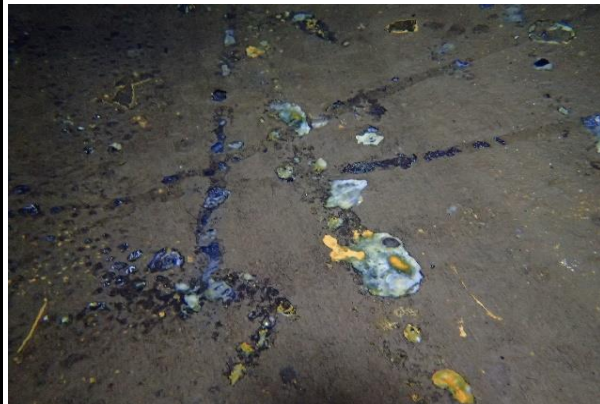
Coating				
Satisfactory	Y	<input type="checkbox"/>	N	<input checked="" type="checkbox"/>
Blistering	Y	<input checked="" type="checkbox"/>	N	<input type="checkbox"/>
Cracking	Y	<input checked="" type="checkbox"/>	N	<input type="checkbox"/>
Peeling	Y	<input type="checkbox"/>	N	<input checked="" type="checkbox"/>
Holidays	Y	<input type="checkbox"/>	N	<input checked="" type="checkbox"/>
Pitting	Y	<input type="checkbox"/>	N	<input checked="" type="checkbox"/>
Corrosion	<5%	Y	<input checked="" type="checkbox"/>	N
Seams/Welds	Fair			
Conclusion/Discrepancies:	Coating is blistered			
a few areas of bare steel with minor corrosion starting				
Sediment Depth	1/4 of an inch

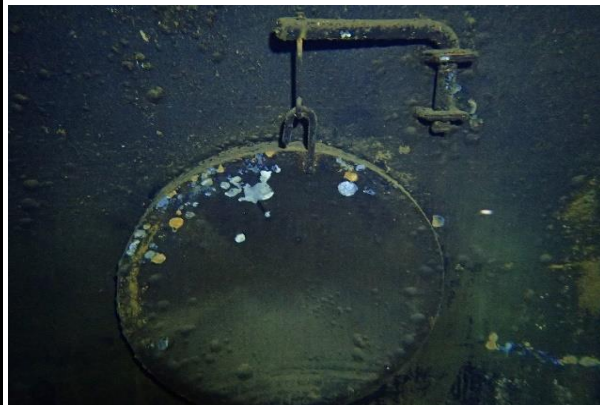
Coating				
Satisfactory	Y	<input type="checkbox"/>	N	<input checked="" type="checkbox"/>
Blistering	Y	<input checked="" type="checkbox"/>	N	<input type="checkbox"/>
Cracking	Y	<input type="checkbox"/>	N	<input checked="" type="checkbox"/>
Peeling	Y	<input type="checkbox"/>	N	<input checked="" type="checkbox"/>
Holidays	Y	<input type="checkbox"/>	N	<input checked="" type="checkbox"/>
Pitting	Y	<input type="checkbox"/>	N	<input checked="" type="checkbox"/>
Corrosion	Y	<input checked="" type="checkbox"/>	N	<input type="checkbox"/>
Seams/Welds	Fair			
Conclusion/Discrepancies:	Coating has failed			
corrosion and blistering around outer edges

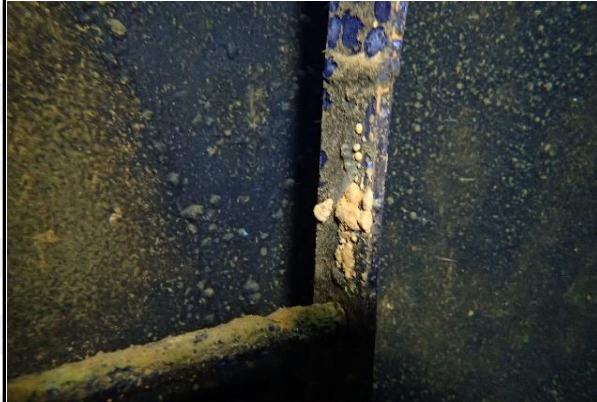
Construction	Coated Steel			
Satisfactory	Y	<input checked="" type="checkbox"/>	N	<input type="checkbox"/>
Coating				
Satisfactory	Y	<input type="checkbox"/>	N	<input checked="" type="checkbox"/>
Blistering	Y	<input checked="" type="checkbox"/>	N	<input type="checkbox"/>
Cracking	Y	<input checked="" type="checkbox"/>	N	<input type="checkbox"/>
Peeling	Y	<input type="checkbox"/>	N	<input checked="" type="checkbox"/>
Holidays	Y	<input type="checkbox"/>	N	<input checked="" type="checkbox"/>
Pitting	Y	<input checked="" type="checkbox"/>	N	<input type="checkbox"/>
Corrosion	15% Y	<input checked="" type="checkbox"/>	N	<input type="checkbox"/>
Seams/Welds	Fair			
Safety Cage/Climb	Y	<input type="checkbox"/>	N	<input checked="" type="checkbox"/>
Conclusion/Discrepancies:	Coating is failing severe blistering with minor corrosion noted.

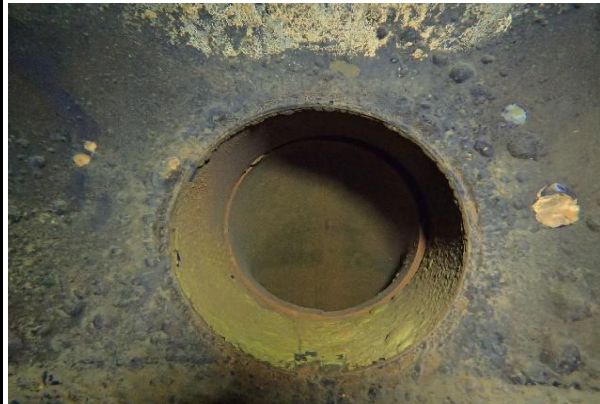
Conclusion/Discrepancies: Minor corrosion around the outer edges with blistering on the interior

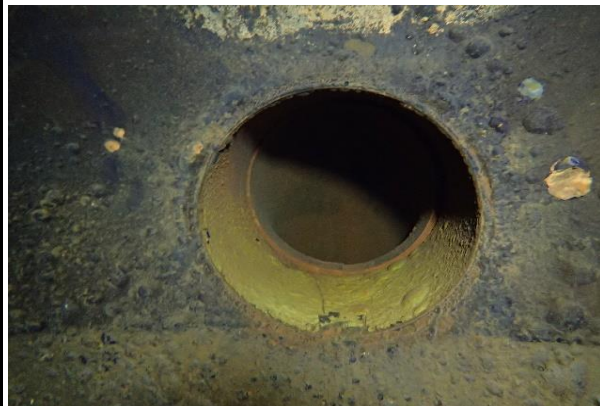
Conclusion/Discrepancies: Minor corrosion around the outer edges with blistering on the interior

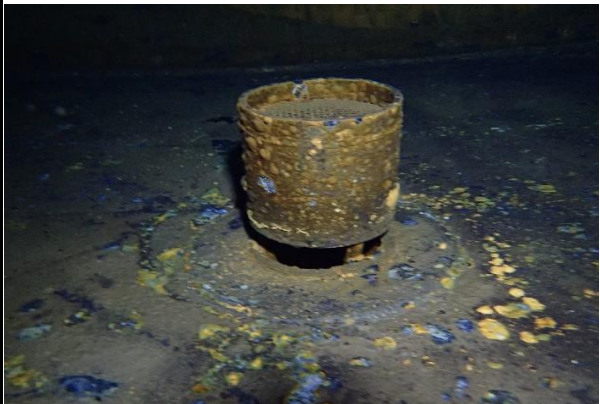
Conclusion/Discrepancies: Corrosion on the screen and interior of the pipe other wise in working condition

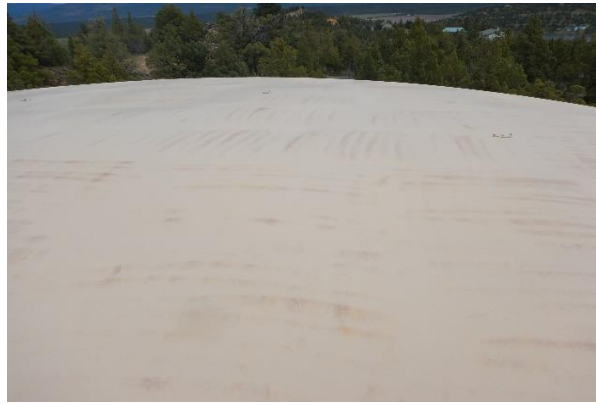
Safety Rail	None			
Satisfactory	<input type="checkbox"/>	N	<input type="checkbox"/>	
Coating				
Welds				
Corrosion	Y	<input type="checkbox"/>	N	<input type="checkbox"/>
Coating				
Satisfactory	Fair	<input checked="" type="checkbox"/>	N	<input type="checkbox"/>
Oxidized	Y	<input checked="" type="checkbox"/>	N	<input type="checkbox"/>
Pitting	Y	<input type="checkbox"/>	N	<input checked="" type="checkbox"/>
Delamination	Y	<input type="checkbox"/>	N	<input checked="" type="checkbox"/>
Corrosion	<2%	Y	<input checked="" type="checkbox"/>	N
Seams/Welds	Good			
Low Spots	Y	<input type="checkbox"/>	N	<input checked="" type="checkbox"/>
Cathodic Protection Plates	Good			
Conclusion/Discrepancies:	The coating is oxidized and thin, the primer is exposed with indications of corrosion starting to form.			
Plan for a new coating in the near future

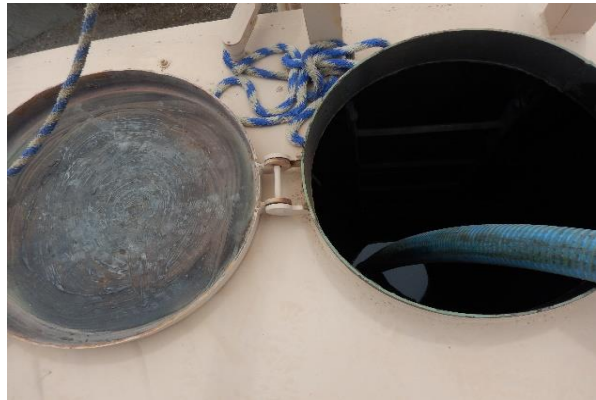
Satisfactory	Y	<input checked="" type="checkbox"/>	N	<input type="checkbox"/>
Coating				
Corrosion	Y	<input checked="" type="checkbox"/>	N	<input type="checkbox"/>
Proper Design	Y	<input checked="" type="checkbox"/>	N	<input type="checkbox"/>
Locked	Y	<input checked="" type="checkbox"/>	N	<input type="checkbox"/>
Gasket	Y	<input type="checkbox"/>	N	<input checked="" type="checkbox"/>
Hinge	Good			
Hatch Size	2	FT	X	FT
Conclusion/Discrepancies	Needs a gasket put in place, minor corrosion where gasket should be

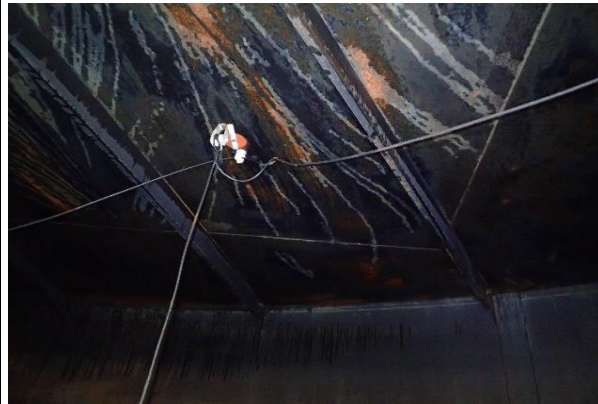
Conclusion/Discrepancies: Surface corrosion covers the plates, minor corrosion on the trusses and hardware. Coating is at the end of its service life and needs redone

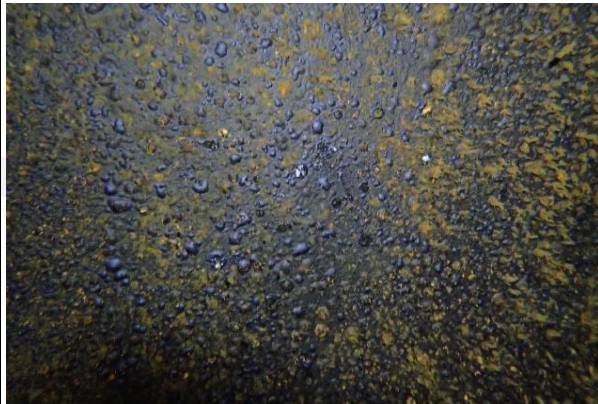
Conclusion/Discrepancies: Weld seams are heavily blistered with corrosion present above the water line corrosion and cracking more extensive

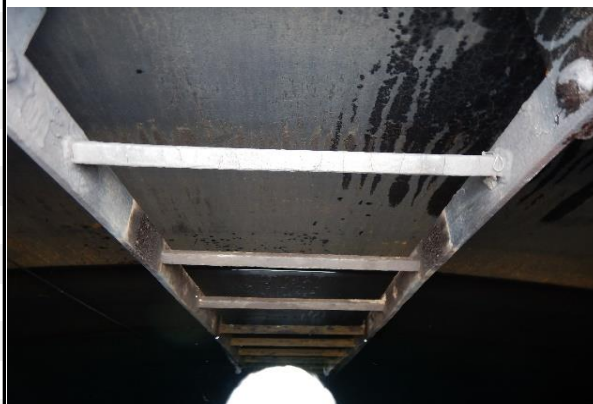
Conclusion/Discrepancies: Coating has failed blistering and bare steel present. Little to no coating present

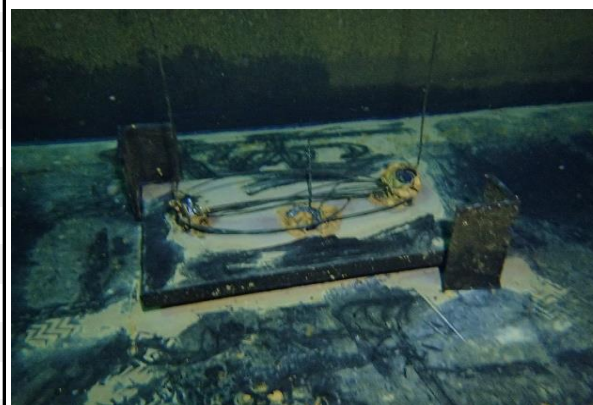
Conclusion/Discrepancies: Corrosion on the floor anchor where the guide wires connect

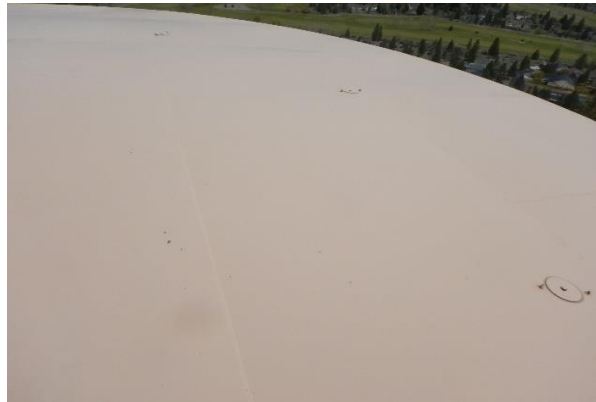
Conclusion/Discrepancies: A few low spots around the outer edges
 Coating is oxidized but in good condition needs minor touch up work
 around the entry hatch

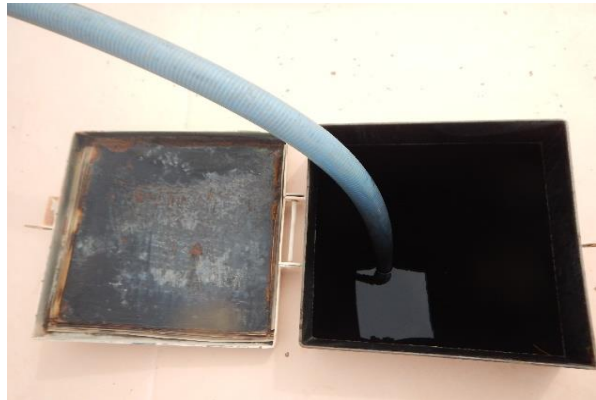
Conclusion/Discrepancies Needs new gasket
 present one is broken and missing parts.
 Corrosion on the underside of the lid

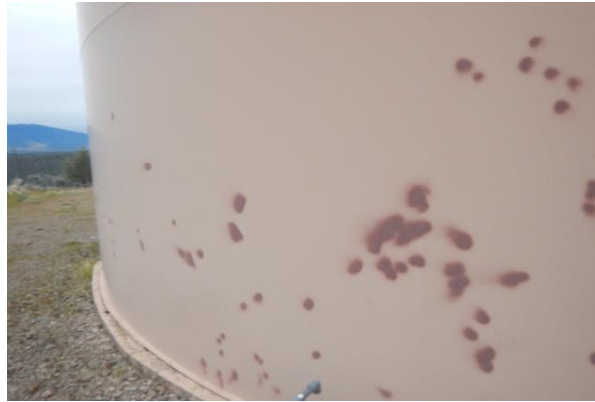
Conclusion/Discrepancies Nicks and scratches that need touch up. Many areas already corrected and appears to be holding up with no corrosion present

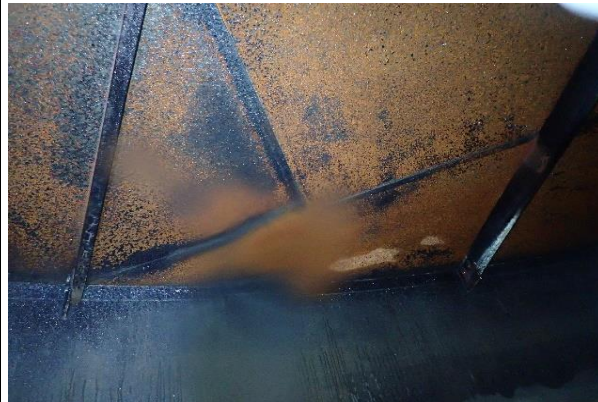
Conclusion/Discrepancies: Surface corrosion covers the plates as well as the trusses and hardware. Coating has failed and needs to be sandblasted and recoated

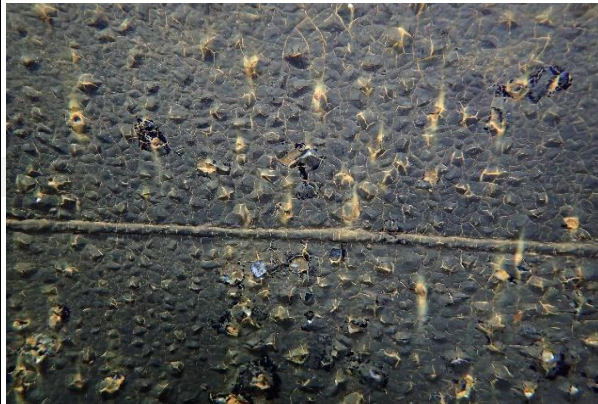
Conclusion/Discrepancies: Coating is severely blistered, most of which have cracked open and corrosion is forming. Sandblast and recoat in the immediate future

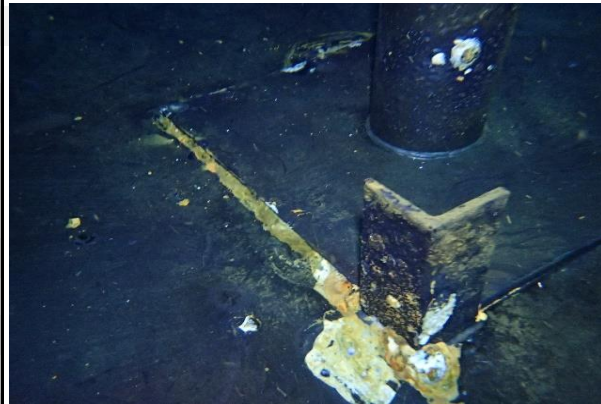
corrosion noted from exposed steel. Coating has failed sandblast and recoat
