Lake Shastina Community Services District Field Report

Underwater Cleaning & Inspection
500,000 Gallon
Tank 1
Potable Water Storage Tank

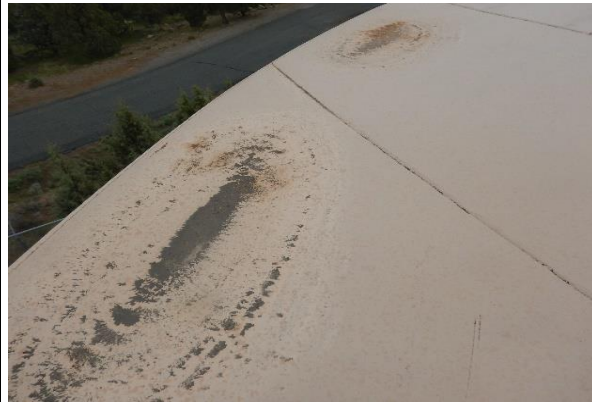
Conclusion/Discrepancies: A few low spots around the outer edges
 Coating is oxidized but in good condition needs minor touch up work
 around the outer edges in the low areas and a few spots near the center
 Hand railing also needs minor touch up work

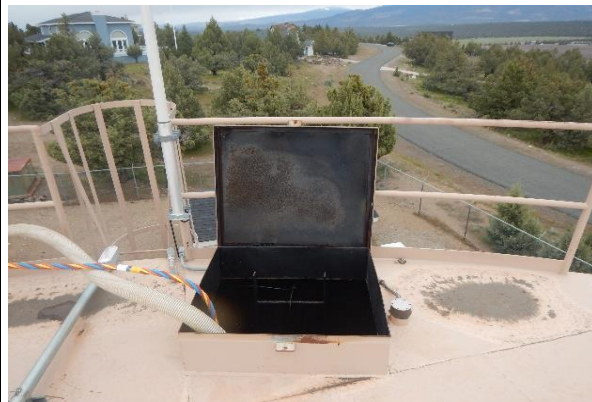
Conclusion/Discrepancies Needs new gasket
 present one is not sealing
 Corrosion on the underside of the lid

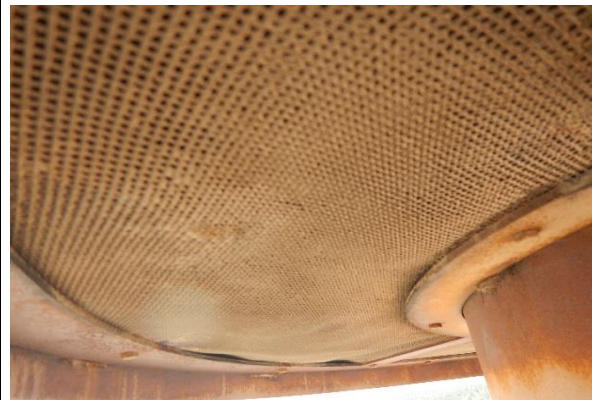
Conclusion/Discrepancies Screen in place and
 well secured Vent is in good condition
 no problematic concerns

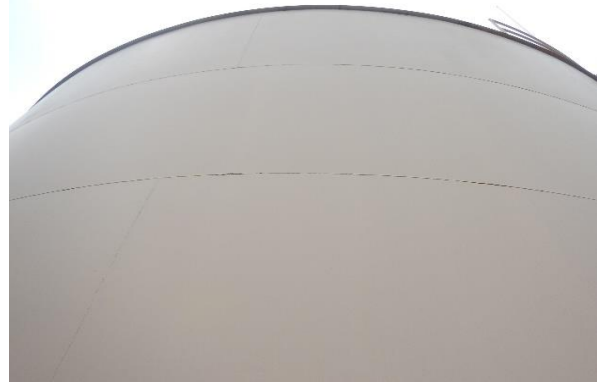
Conclusion/Discrepancies Coating is oxidized but holding up well no discrepancies noted

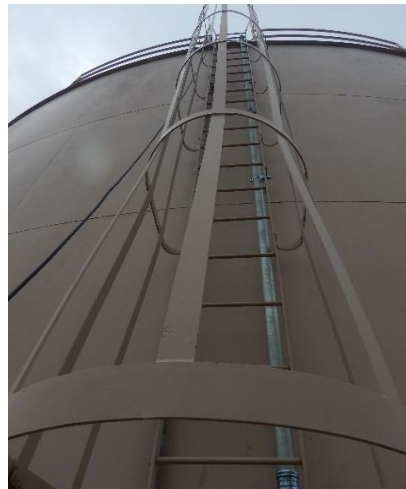
Conclusion/Discrepancies Ladder, cage and braces all in working condition, minor rust noted

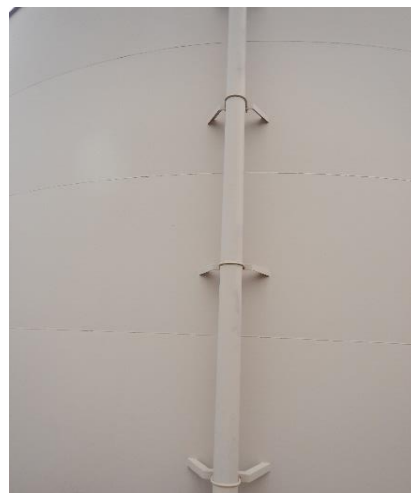
Conclusion/Discrepancies Pipe and braces are in good condition with minor rust that needs touched up on the back side of the pipe

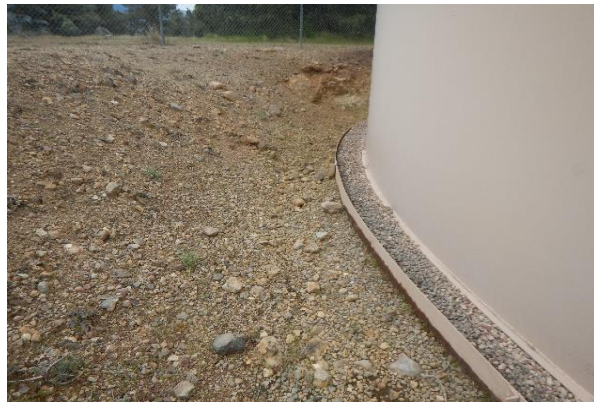
Concrete Slab/Ring Retention				
Satisfactory	Y	<input type="checkbox"/>	N	<input type="checkbox"/>
Cracking	Y	<input type="checkbox"/>	N	<input checked="" type="checkbox"/>
Spalling	Y	<input type="checkbox"/>	N	<input checked="" type="checkbox"/>
Exposed Aggregate	Y	<input type="checkbox"/>	N	<input checked="" type="checkbox"/>
Erosion Undermining	Y	<input type="checkbox"/>	N	<input checked="" type="checkbox"/>
Seismic Restraints None				
Corrosion	Y	<input type="checkbox"/>	N	<input type="checkbox"/>
Tight	Y	<input type="checkbox"/>	N	<input type="checkbox"/>
Conclusion/Discrepancies Retention ring in place and in good condition no undermining or erosion noted overall satisfactory

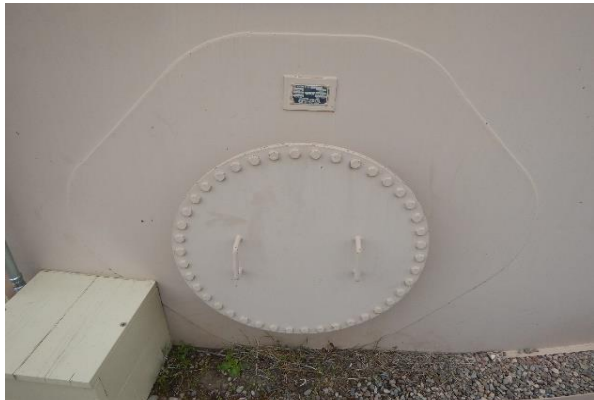
MANUAL LEVEL INDICATOR

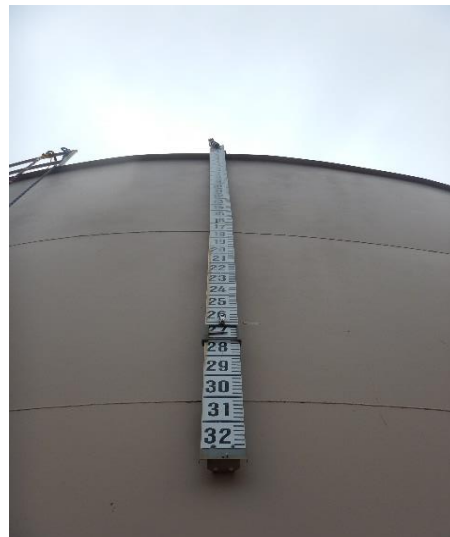
Conclusion/Discrepancies: Indicator appears to be in good condition

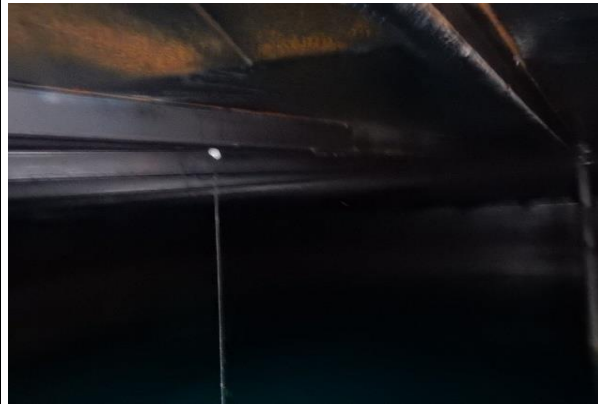
Conclusion/Discrepancies: Surface corrosion covers the plates, minor corrosion on the trusses and hardware. Coating is at the end of its service life and needs redone

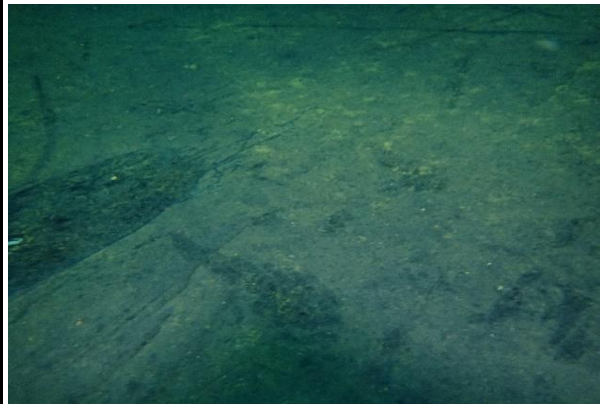
Coating				
Satisfactory	Fair	<input checked="" type="checkbox"/>	N	<input type="checkbox"/>
Blistering	Y	<input checked="" type="checkbox"/>	N	<input type="checkbox"/>
Cracking	Y	<input type="checkbox"/>	N	<input checked="" type="checkbox"/>
Peeling	Y	<input type="checkbox"/>	N	<input checked="" type="checkbox"/>
Holidays	Y	<input type="checkbox"/>	N	<input checked="" type="checkbox"/>
Pitting	Y	<input type="checkbox"/>	N	<input checked="" type="checkbox"/>
Corrosion	3%	Y	<input checked="" type="checkbox"/>	N
Seams/Welds	Fair			
Conclusion/Discrepancies:	Majority if the coating is in good shape with no major discrepancies A few sporadic spots of corrosion / bare steel			
Sediment Depth	1/4 of an inch

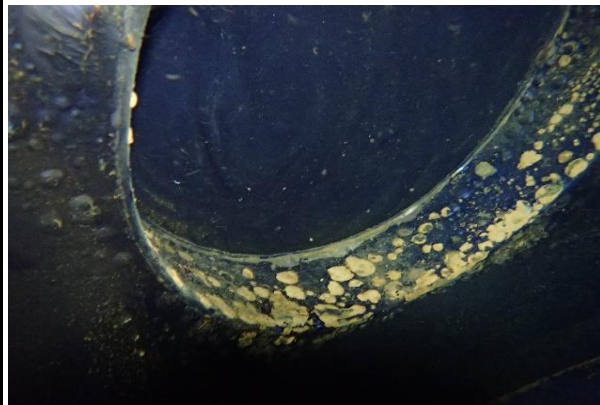
Coating				
Satisfactory	Y	<input type="checkbox"/>	N	<input checked="" type="checkbox"/>
Blistering	Y	<input checked="" type="checkbox"/>	N	<input type="checkbox"/>
Cracking	Y	<input type="checkbox"/>	N	<input checked="" type="checkbox"/>
Peeling	Y	<input type="checkbox"/>	N	<input checked="" type="checkbox"/>
Holidays	Y	<input type="checkbox"/>	N	<input checked="" type="checkbox"/>
Pitting	Y	<input type="checkbox"/>	N	<input checked="" type="checkbox"/>
Corrosion	10%	Y	<input checked="" type="checkbox"/>	N
Seams/Welds	Fair			
Conclusion/Discrepancies:	Blistering and surface corrosion noted around the outer edges and interior of the doorway extension

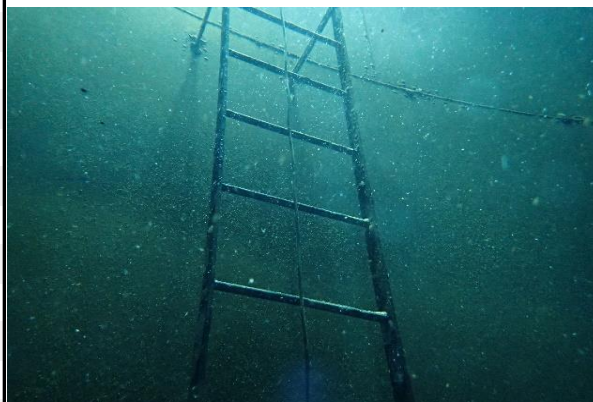
Conclusion/Discrepancies: Coating has failed blistering and bare steel present. Little to no corrosion present

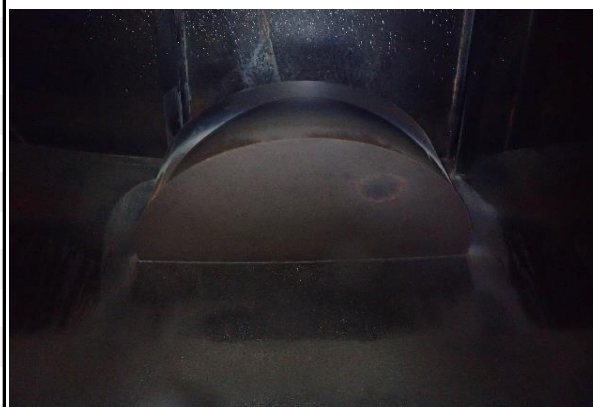
MANUAL LEVEL INDICATOR

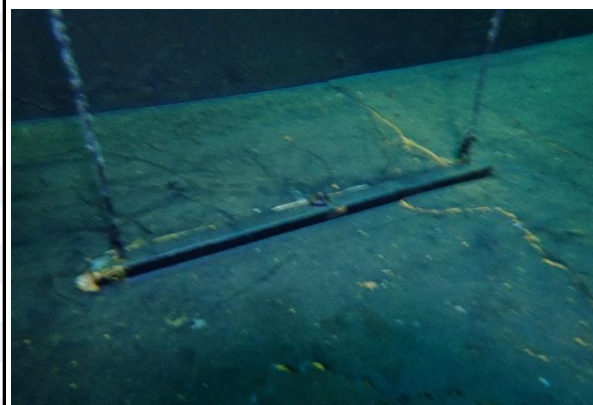
Conclusion/Discrepancies: Minor corrosion on the floor anchor otherwise in good condition

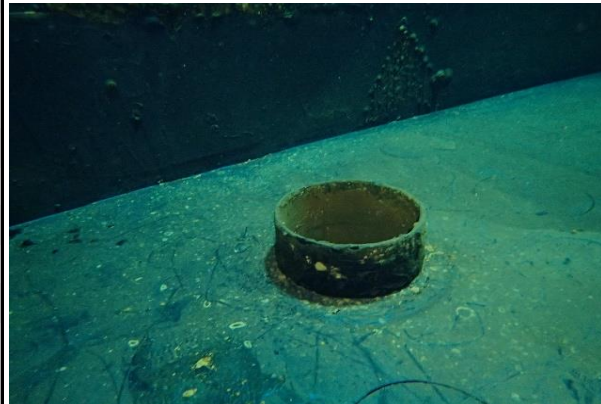
Conclusion/Discrepancies: Blistering and corrosion noted around the top edge of the pipe

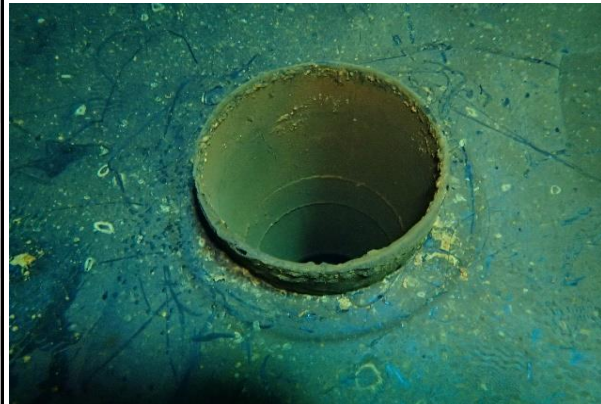
Conclusion/Discrepancies: Blistering and corrosion noted around the weld seam

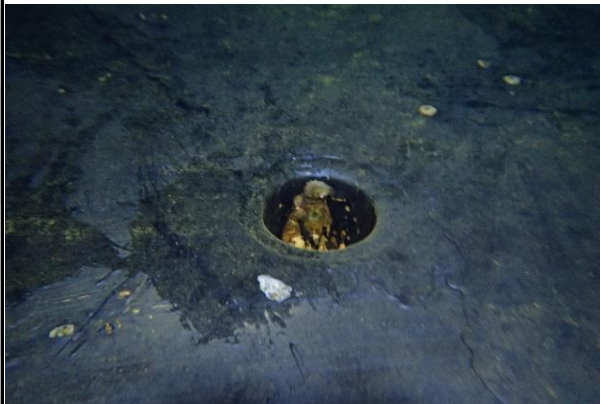
Conclusion/Discrepancies: Corrosion on the interior of the pipe. Welds and coating are intact and in good condition
