Lake Shastina Community Services District Field Report

Underwater Cleaning & Inspection
250,000 Gallon
Tank 4
Potable Water Storage Tank

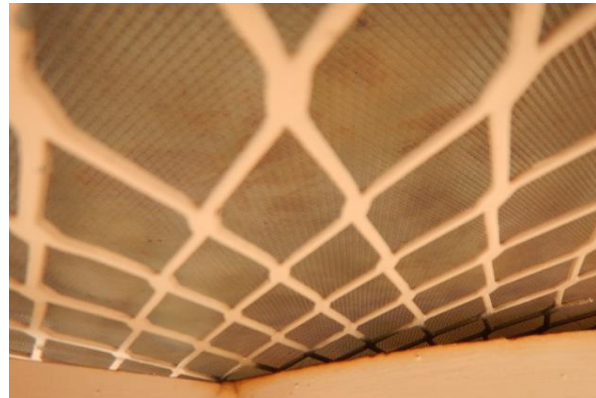
Conclusion/Discrepancies Screen in place and
 well secured Vent is in good condition
 no problematic concerns

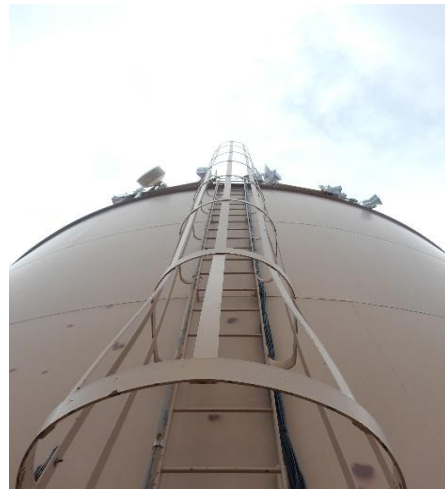
Conclusion/Discrepancies Ladder, cage and braces all in working condition, minor rust noted

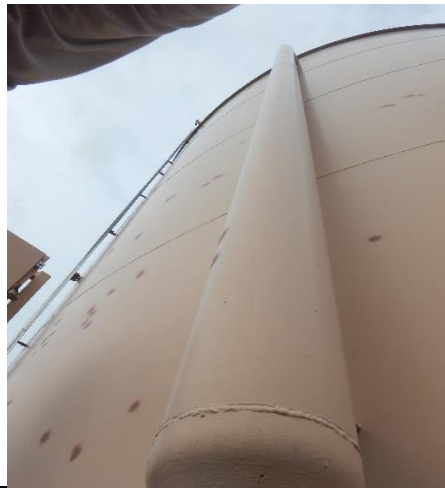
Attachments In ground
Foundation Good
Conclusion/Discrepancies Pipe and braces are in good condition with minor rust that needs touched up

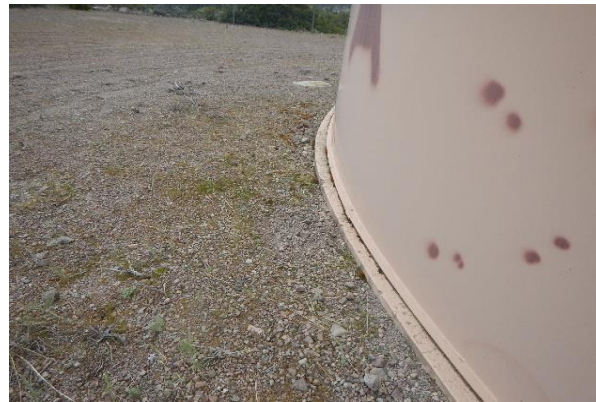
Conclusion/Discrepancies Minor superficial cracks noted in the concrete. No undermining or erosion noted overall satisfactory

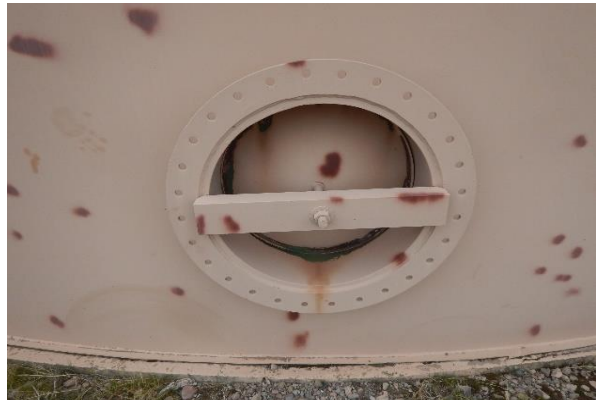
MANUAL LEVEL INDICATOR

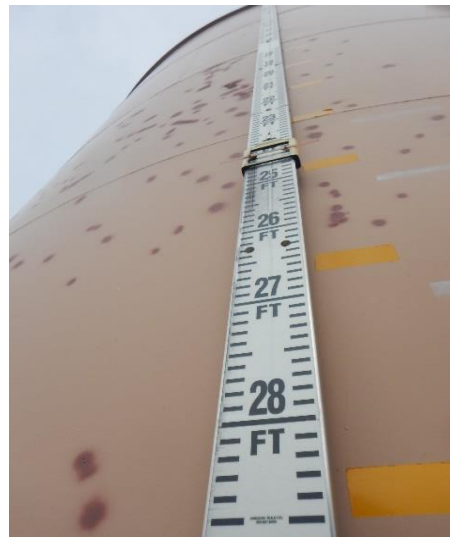
Conclusion/Discrepancies: Indicator appears to be in good condition

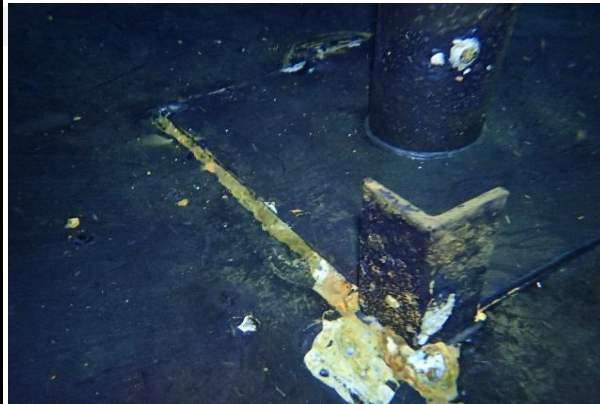
Coating				
Satisfactory	Y	<input type="checkbox"/>	N	<input checked="" type="checkbox"/>
Blistering	Y	<input checked="" type="checkbox"/>	N	<input type="checkbox"/>
Cracking	Y	<input checked="" type="checkbox"/>	N	<input type="checkbox"/>
Peeling	Y	<input type="checkbox"/>	N	<input checked="" type="checkbox"/>
Holidays	Y	<input type="checkbox"/>	N	<input checked="" type="checkbox"/>
Pitting	Y	<input type="checkbox"/>	N	<input checked="" type="checkbox"/>
Corrosion	5%	Y	<input checked="" type="checkbox"/>	N
Seams/Welds	Fair			
Floor/Base Plates	Fair			
Construction	Coated steel			
Conclusion/Discrepancies:	Blistering and surface corrosion noted from exposed steel. Coating has failed sandblast and recoat

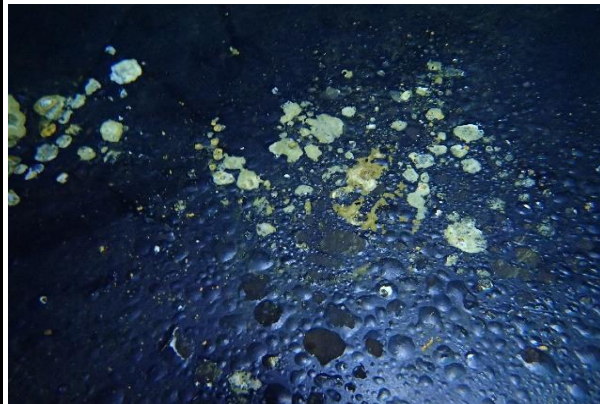
Coating				
Satisfactory	Y	<input type="checkbox"/>	N	<input checked="" type="checkbox"/>
Blistering	Y	<input checked="" type="checkbox"/>	N	<input type="checkbox"/>
Cracking	Y	<input type="checkbox"/>	N	<input checked="" type="checkbox"/>
Peeling	Y	<input type="checkbox"/>	N	<input checked="" type="checkbox"/>
Holidays	Y	<input type="checkbox"/>	N	<input checked="" type="checkbox"/>
Pitting	Y	<input type="checkbox"/>	N	<input checked="" type="checkbox"/>
Corrosion	10%	Y	<input checked="" type="checkbox"/>	N
Seams/Welds	Fair			
Conclusion/Discrepancies:	Large areas of bare steel, minimal corrosion cathodic protection is working properly coating has failed			
Sediment Depth	1/8 of an inch

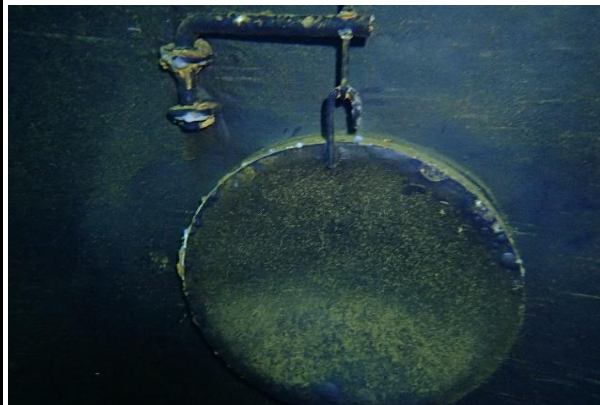
Coating				
Satisfactory	Y	<input type="checkbox"/>	N	<input checked="" type="checkbox"/>
Blistering	Y	<input checked="" type="checkbox"/>	N	<input type="checkbox"/>
Cracking	Y	<input type="checkbox"/>	N	<input checked="" type="checkbox"/>
Peeling	Y	<input type="checkbox"/>	N	<input checked="" type="checkbox"/>
Holidays	Y	<input type="checkbox"/>	N	<input checked="" type="checkbox"/>
Pitting	Y	<input type="checkbox"/>	N	<input checked="" type="checkbox"/>
Corrosion	5%	Y	<input checked="" type="checkbox"/>	N
Seams/Welds	Fair			
Conclusion/Discrepancies:	Blistering and surface corrosion noted around the outer edges			
Hanger and hardware also exhibit corrosion and blistering

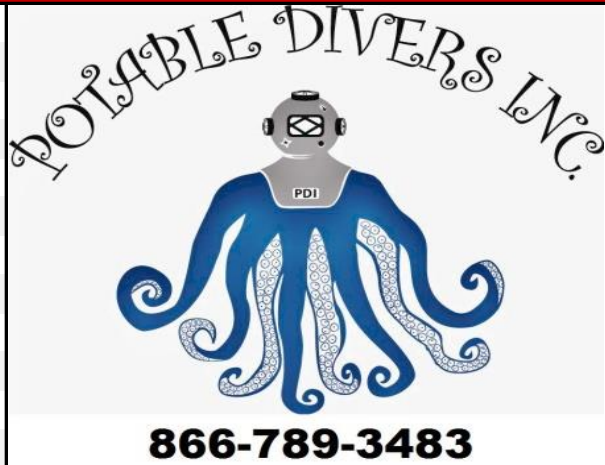
Construction	None			
Satisfactory	Y	<input type="checkbox"/>	N	<input type="checkbox"/>
Coating				
Satisfactory	Y	<input type="checkbox"/>	N	<input type="checkbox"/>
Blistering	Y	<input type="checkbox"/>	N	<input type="checkbox"/>
Cracking	Y	<input type="checkbox"/>	N	<input type="checkbox"/>
Peeling	Y	<input type="checkbox"/>	N	<input type="checkbox"/>
Holidays	Y	<input type="checkbox"/>	N	<input type="checkbox"/>
Pitting	Y	<input type="checkbox"/>	N	<input type="checkbox"/>
Corrosion	%	Y <input type="checkbox"/>	N	<input type="checkbox"/>
Seams/Welds				
Safety Cage/Climb	Y	<input type="checkbox"/>	N	<input type="checkbox"/>
Conclusion/Discrepancies:				
No interior ladder

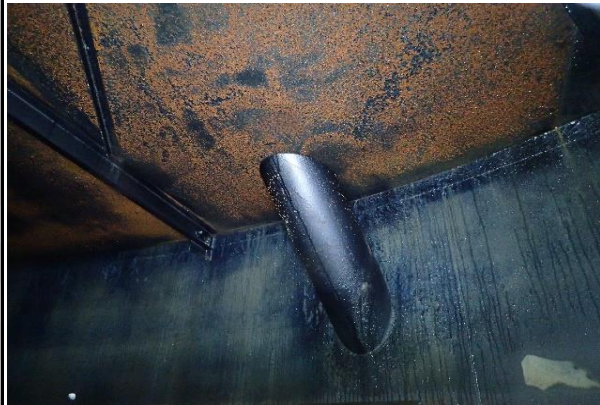
MANUAL LEVEL INDICATOR

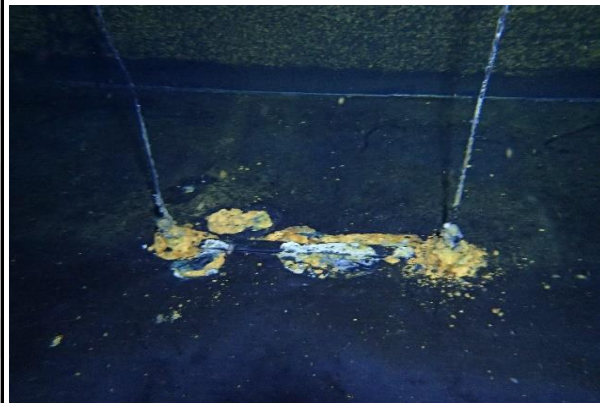
Float	Y	<input checked="" type="checkbox"/>	N	<input type="checkbox"/>
Guide Wires	Y	<input checked="" type="checkbox"/>	N	<input type="checkbox"/>
Guide Wire Anchors	Y	<input checked="" type="checkbox"/>	N	<input type="checkbox"/>
Cable / Hardware	Y	<input checked="" type="checkbox"/>	N	<input type="checkbox"/>
Corrosion	15%	Y <input checked="" type="checkbox"/>	N	<input type="checkbox"/>
Operation	Y	<input checked="" type="checkbox"/>	N	<input type="checkbox"/>
Conclusion/Discrepancies:				
Corrosion on the guide wire anchors, system is in working condition, float has some water on the interior and is losing buoyancy

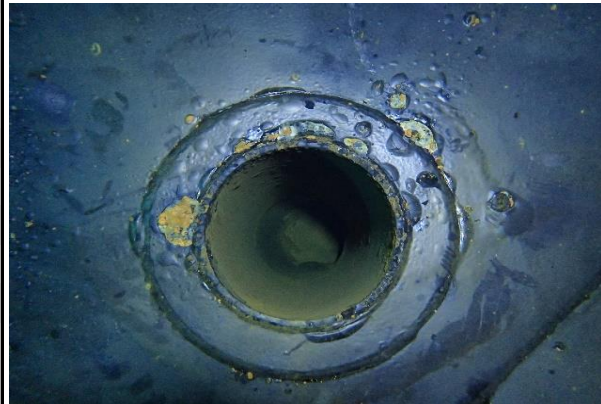
Conclusion/Discrepancies: Blistering and corrosion noted around the weld seam

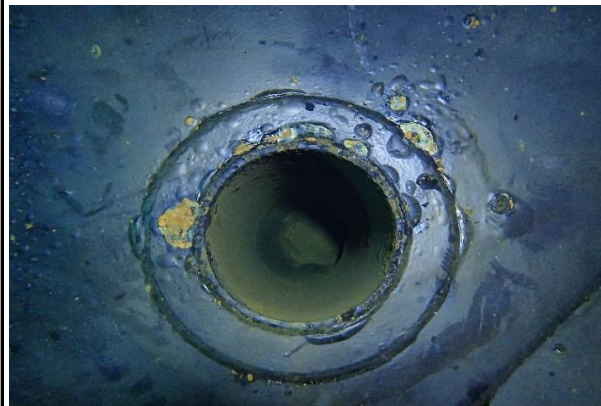
Conclusion/Discrepancies: Blistering and corrosion noted around the weld seam

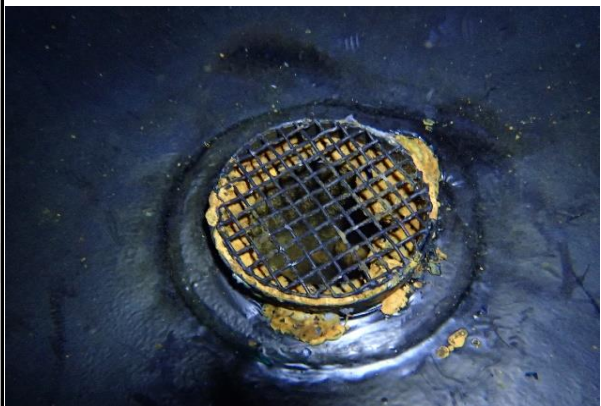
Conclusion/Discrepancies: Corrosion around the weld seam and on the interior of the pipe
