Draft Preliminary Engineering Report

Drinking Water System Improvements

Lake Shastina Community Services District

December 2023

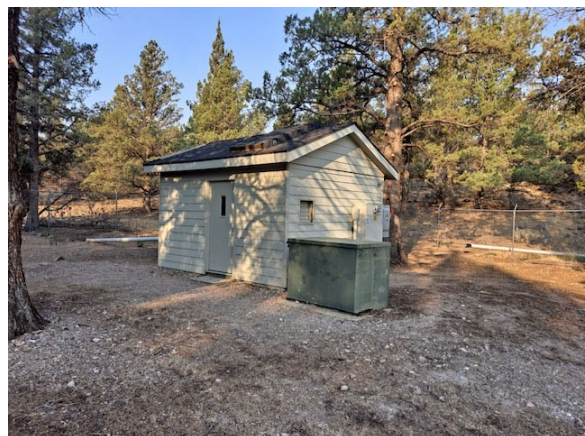
Photograph 3.3 Well #9 Well House

Well 9 has a 100-hp, 700-gpm turbine pump, drawing water from 80 feet below the ground surface, and the elevation of the pump is roughly 2,745 feet. This well does not have electrical connections for the LSCSD mobile generator, and there is no permanent electrical backup supply to keep this well running in the event of an electrical outage. Figure 3-5 shows a piping schematic for this well.

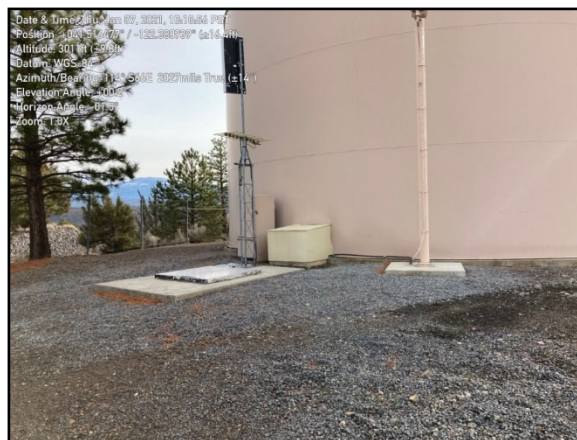
Photograph 3.5 Stag Tank (Tank 2).

Erected in 1971, Tank 2 (Photograph 3.5) is a 300,000-gallon cylindrical welded-steel tank that has external dimensions of 24 feet tall by 47 feet in diameter.

An inspection performed in April 2017 (Appendix 1) had the following findings:

The inspection report made the following recommendations to address the deficiencies:

- Sandblast and recoat the interior coating.
- Replace the entry hatch gasket.
- Touch up the exterior coating in areas with nicks and scratches.

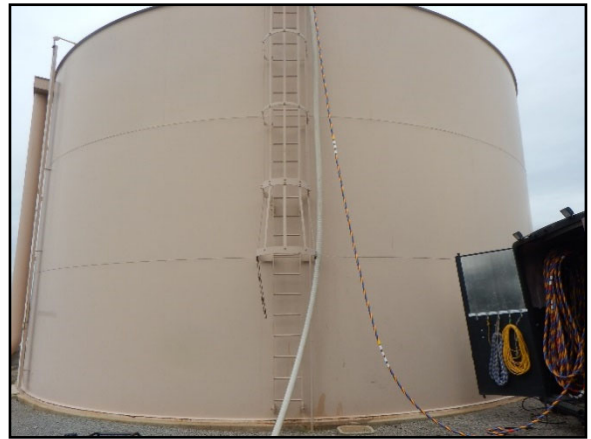
Photograph 3.6 Rancho Tank (Tank 3).

Erected in 1974, Tank 3 (Photograph 3.6) is a 300,000-gallon cylindrical welded-steel tank that has external dimensions of 24 feet tall and 47 feet in diameter. This tank is at the corner of Stone Crest Drive and Eagle Rest Court, in the Rancho Hills subdivision (see Figure 3-10 for location). Figure 3-11 shows the piping schematic for this tank. The base elevation of this tank is 3,020 feet.

An inspection performed in April 2017 (Appendix 1) had the following findings:

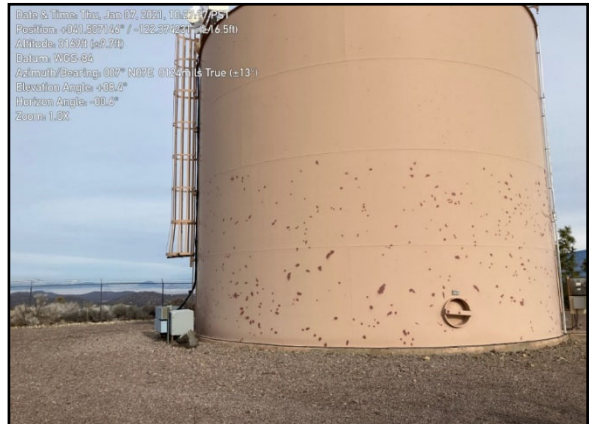
Photograph 3.7 Zen Mountain Tank (Tank 4).

Erected in 1977, Tank 4 (Photograph 3.7) is a 250,000-gallon cylindrical welded-steel tank with external dimensions of 30 feet in height and 38 feet in diameter. It is located at the top of Zen Mountain (Figure 3-12). Figure 3-13 shows the piping schematic for this tank. The closest street is Tennis Court, which also is the beginning of the access road to this tank. The base elevation of this tank is approximately 3,160 feet.

An inspection performed in April 2017 (Appendix 1) had the following findings:

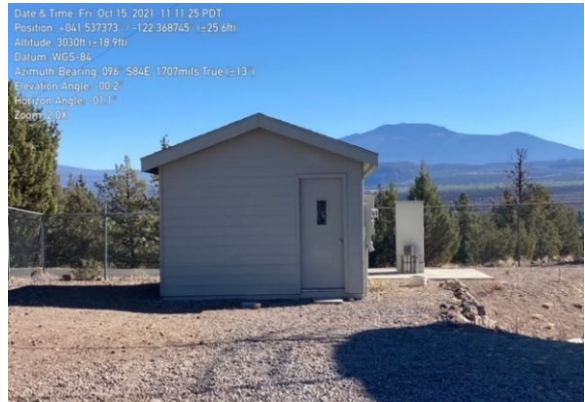
Photograph 3.8 Booster Pump Station B-50

Booster Pump Station B-50 (Photograph 3.8) is located adjacent to Tank 1 and provides a local pressure zone where the homes surrounding the tank are at approximately the same elevation as Tank 1. The location is shown in Figure 3-1 and the piping schematic is shown on Figure 3-14. This pump station consists of two 45-gpm pony pumps, one 300-gpm pump, and four 75-gallon pressure tanks. This pump station is in fair condition.

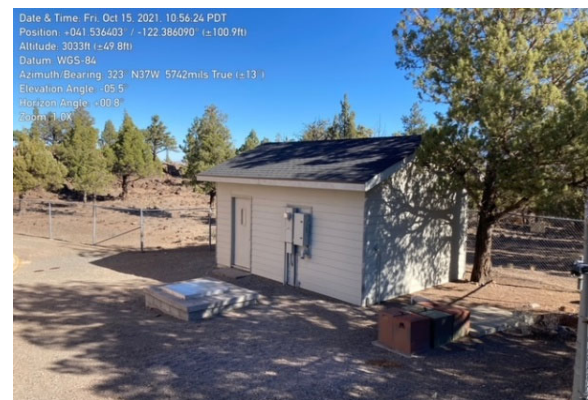
Photograph 3.10 Booster Pump Station B-56

Booster Pump Station B-56 (Photograph 3.10) is located adjacent to Tank 3 and provides a local pressure zone where the homes surrounding the tank are at approximately the same elevation as Tank 3. The location is shown on Figure 3-1 and the piping schematic is shown on Figure 3-16. This pump station consists of two 45-gpm pony pumps, one 400-gpm pump, and three 75-gallon pressure tanks. This pump station is in fair condition.

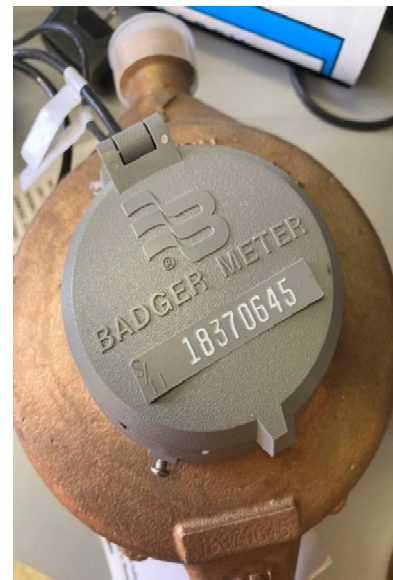
Photograph 3.13 Typical Water Meter

The LSCSD has two types of meters: 1) system meters and 2) customer meters. The system meters, which primarily provide volumetric data for reporting purposes, are in good condition. The customer meters, which number 1,292, need replacement.

The customer meters are nearing the end of their useful life. Further, LSCSD staff manually read each meter quarterly for the purpose of billing. LSCSD employees currently spend approximately 128 person-hours (estimated 4 people working 8 hours a day for

Note: LSCSD is using this type of manual read meter.

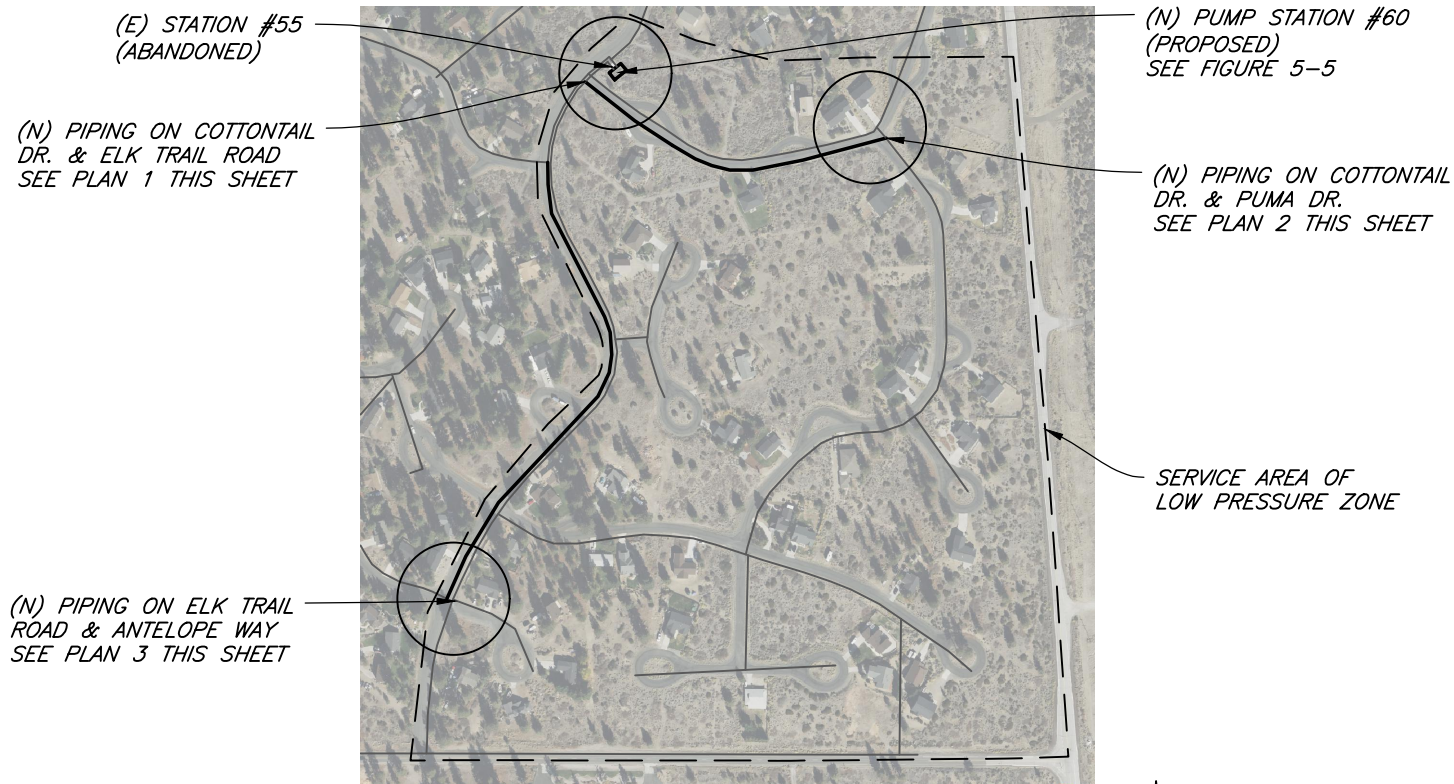
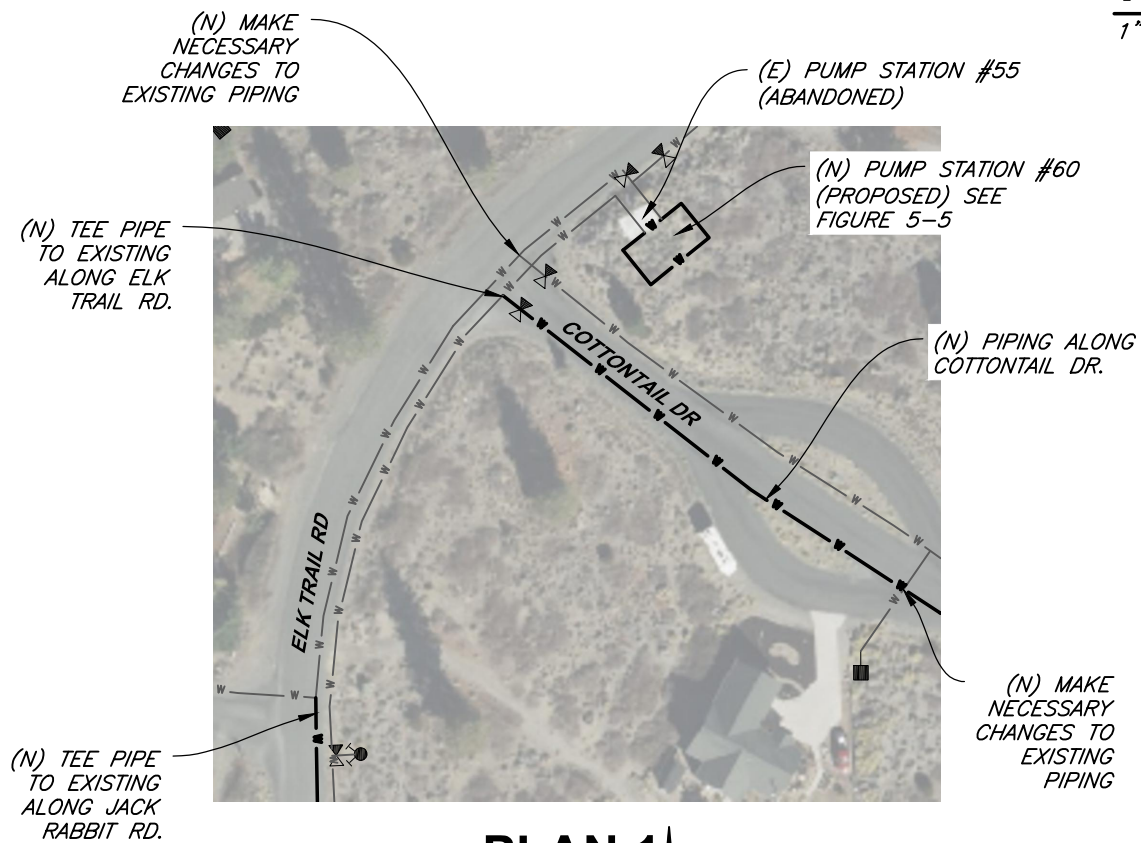
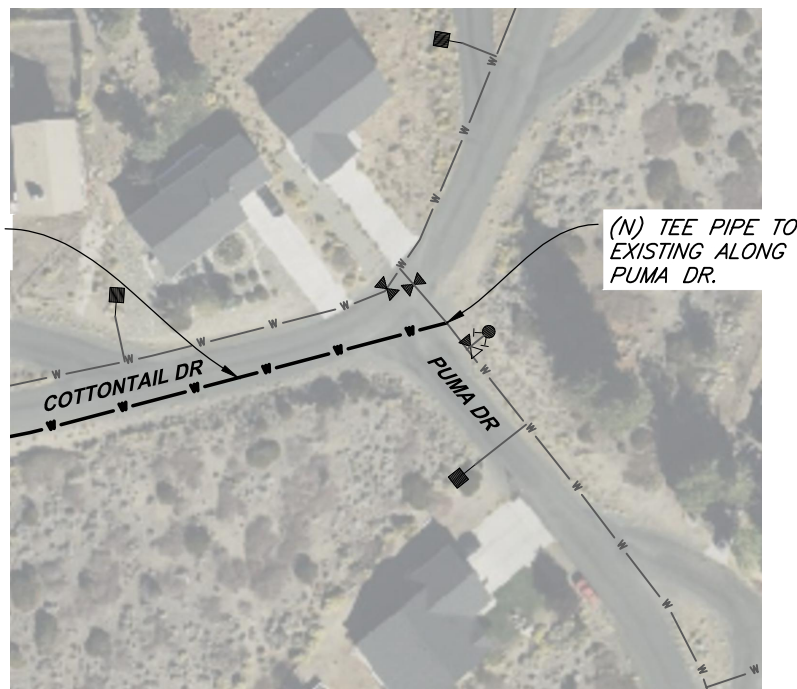
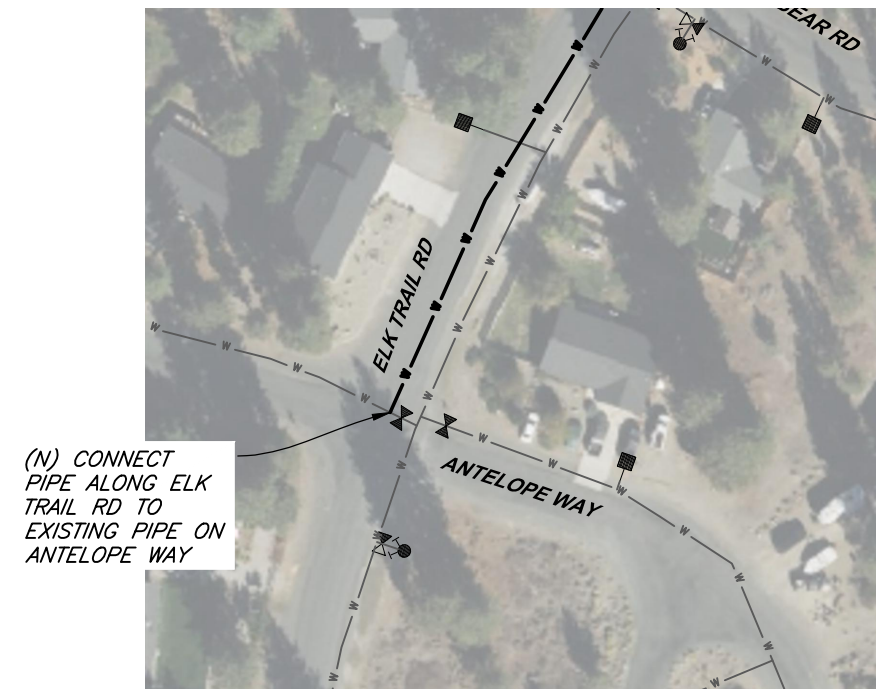
To provide adequate system pressures in the southern area, additional energy must be supplied to the system. This can be accomplished by installing an additional booster pump or water tank at a higher elevation, or both simultaneously. Figure 5-4 shows the proposed location for this new booster pump station, which is at the site of a former booster pump station at the corner of Elk Trail Road and Cottontail Drive. Figure 5-5 shows the piping schematic for this new booster pump station.

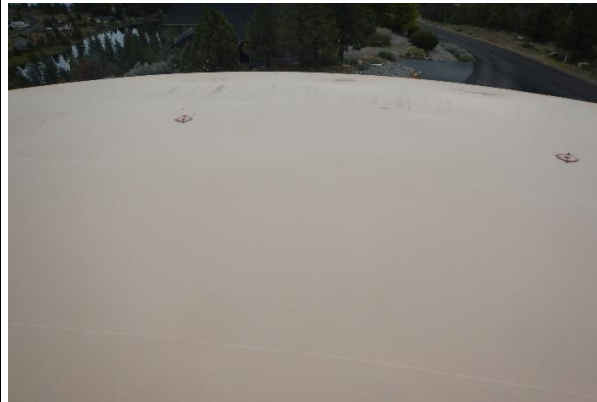
EXTERIOR ROOF

Safety Rail			
Satisfactory	Y	<input checked="" type="checkbox"/>	N <input type="checkbox"/>
Coating	Oxidized and thin		
Welds	Good		
Corrosion	Y	<input type="checkbox"/>	N <input checked="" type="checkbox"/>
Coating			
Satisfactory	Fair	<input checked="" type="checkbox"/>	N <input type="checkbox"/>
Oxidized	Y	<input checked="" type="checkbox"/>	N <input type="checkbox"/>
Pitting	Y	<input type="checkbox"/>	N <input checked="" type="checkbox"/>
Delamination	Y	<input type="checkbox"/>	N <input checked="" type="checkbox"/>
Corrosion	Y	<input type="checkbox"/>	N <input checked="" type="checkbox"/>
Seams/Welds	Good		
Low Spots	Y	<input checked="" type="checkbox"/>	N <input type="checkbox"/>

Conclusion/Discrepancies: Coating is thin and oxidized primer still intact corrosion very minimal. A few low spots around the outer edges with surface water staining noted
Cathodic plates are in place and well secured with no corrosion

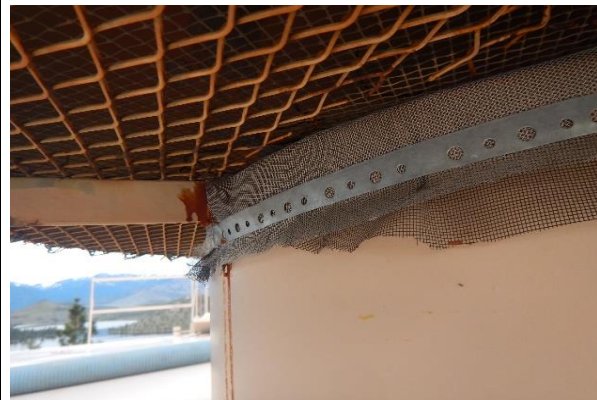
VENTS

Satisfactory	Y	<input checked="" type="checkbox"/>	N <input type="checkbox"/>
Coating			
Corrosion	<2% Y	<input checked="" type="checkbox"/>	N <input type="checkbox"/>
Proper Design	Y	<input checked="" type="checkbox"/>	N <input type="checkbox"/>
Screens	Y	<input checked="" type="checkbox"/>	N <input type="checkbox"/>
Sealed Edges & Seams	Y	<input checked="" type="checkbox"/>	N <input type="checkbox"/>
Cap/Cover	Y	<input checked="" type="checkbox"/>	N <input type="checkbox"/>

Conclusion/Discrepancies Vent is in good condition with proper 24 gauge screen in place minor rust staining from the humidity escaping from the vent

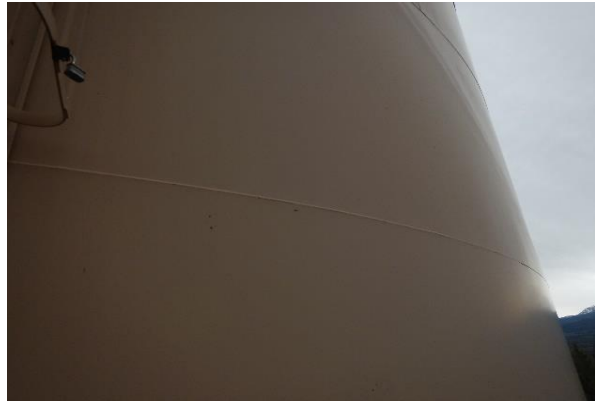
EXTERIOR SHELL

Satisfactory	Y	<input checked="" type="checkbox"/>	N	<input type="checkbox"/>
Oxidized	Y	<input checked="" type="checkbox"/>	N	<input type="checkbox"/>
Pitting	Y	<input type="checkbox"/>	N	<input checked="" type="checkbox"/>
Delamination	Y	<input type="checkbox"/>	N	<input checked="" type="checkbox"/>
Corrosion <2%	Y	<input checked="" type="checkbox"/>	N	<input type="checkbox"/>

Conclusion/Discrepancies Minor nicks and scratches, no coating adhesion problems shell is in satisfactory condition

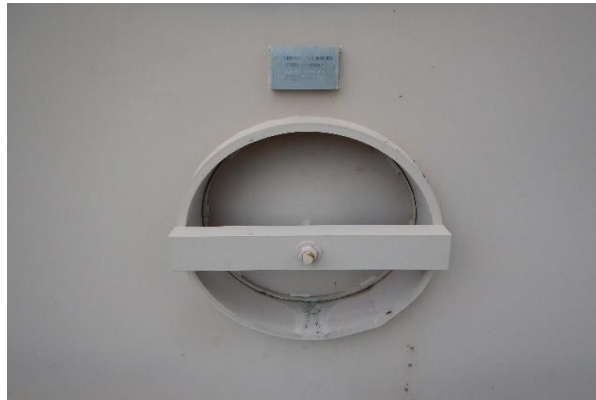
MANUAL LEVEL INDICATOR

Float	Y	<input checked="" type="checkbox"/>	N	<input type="checkbox"/>	
Guide Wires	Y	<input checked="" type="checkbox"/>	N	<input type="checkbox"/>	
Guide Wire Anchors	Y	<input checked="" type="checkbox"/>	N	<input type="checkbox"/>	
Cable / Hardware	Y	<input checked="" type="checkbox"/>	N	<input type="checkbox"/>	
Corrosion	%	Y	<input type="checkbox"/>	N	<input checked="" type="checkbox"/>
Operation	Y	<input checked="" type="checkbox"/>	N	<input type="checkbox"/>	
Conclusion/Discrepancies: All hardware is present and appears to be working properly

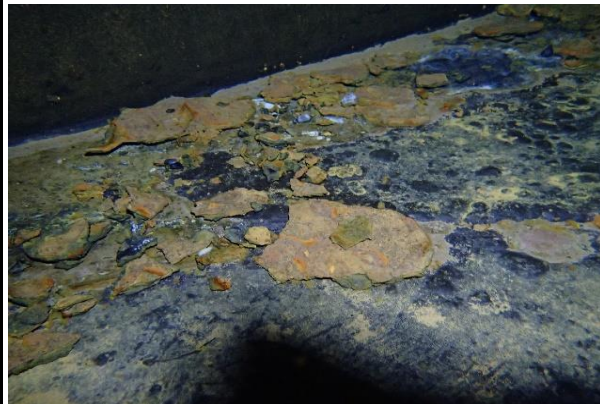
MANWAY ENTRIES

Coating				
Satisfactory	Y	<input type="checkbox"/>	N	<input checked="" type="checkbox"/>
Blistering	Y	<input checked="" type="checkbox"/>	N	<input type="checkbox"/>
Cracking	Y	<input type="checkbox"/>	N	<input checked="" type="checkbox"/>
Peeling	Y	<input type="checkbox"/>	N	<input checked="" type="checkbox"/>
Holidays	Y	<input type="checkbox"/>	N	<input checked="" type="checkbox"/>
Pitting	Y	<input type="checkbox"/>	N	<input checked="" type="checkbox"/>
Corrosion	5%	Y	<input checked="" type="checkbox"/>	N
Seams/Welds	Fair			
Conclusion/Discrepancies:	Blistering and surface corrosion noted around the outer edges and interior of the doorway extension

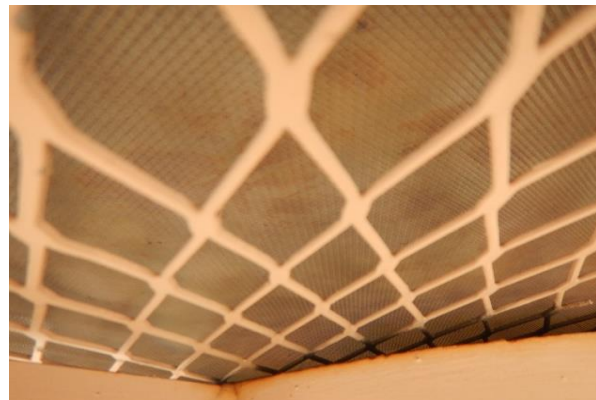
VENTS

Satisfactory	Y	<input checked="" type="checkbox"/>	N <input type="checkbox"/>
Coating			
Corrosion	% Y	<input type="checkbox"/>	N <input checked="" type="checkbox"/>
Proper Design	Y	<input checked="" type="checkbox"/>	N <input type="checkbox"/>
Screens	Y	<input checked="" type="checkbox"/>	N <input type="checkbox"/>
Sealed Edges & Seams	Y	<input checked="" type="checkbox"/>	N <input type="checkbox"/>
Cap/Cover	Y	<input checked="" type="checkbox"/>	N <input type="checkbox"/>

Conclusion/Discrepancies Screen in place and
 well secured Vent is in good condition
 no problematic concerns

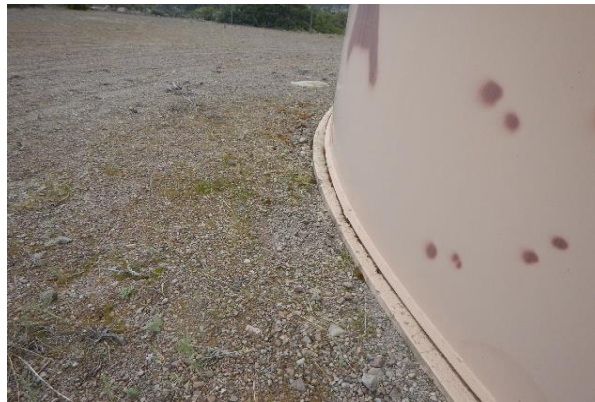
MANWAY ENTRIES

Coating					
Satisfactory	Y	<input type="checkbox"/>	N	<input checked="" type="checkbox"/>	
Oxidized	Y	<input checked="" type="checkbox"/>	N	<input type="checkbox"/>	
Pitting	Y	<input type="checkbox"/>	N	<input checked="" type="checkbox"/>	
Delamination	Y	<input checked="" type="checkbox"/>	N	<input type="checkbox"/>	
Corrosion	5%	Y	<input checked="" type="checkbox"/>	N	<input type="checkbox"/>
Welds/Joints Fair					
Conclusion/Discrepancies Needs touch up work around the edges of the doorway as the coating is peeling

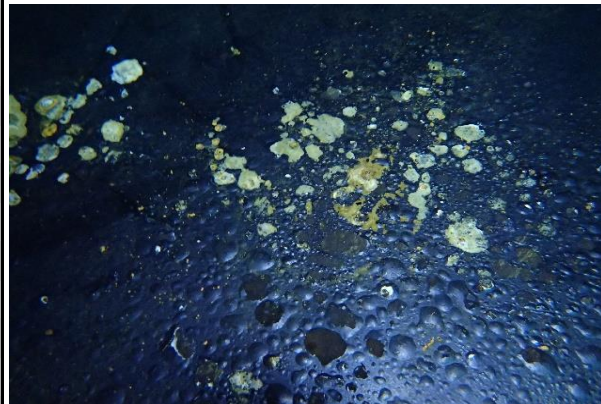
MANWAY ENTRIES

Coating				
Satisfactory	Y	<input type="checkbox"/>	N	<input checked="" type="checkbox"/>
Blistering	Y	<input checked="" type="checkbox"/>	N	<input type="checkbox"/>
Cracking	Y	<input type="checkbox"/>	N	<input checked="" type="checkbox"/>
Peeling	Y	<input type="checkbox"/>	N	<input checked="" type="checkbox"/>
Holidays	Y	<input type="checkbox"/>	N	<input checked="" type="checkbox"/>
Pitting	Y	<input type="checkbox"/>	N	<input checked="" type="checkbox"/>
Corrosion	5%	Y	<input checked="" type="checkbox"/>	N
Seams/Welds	Fair			
Conclusion/Discrepancies:	Blistering and surface corrosion noted around the outer edges			
Hanger and hardware also exhibit corrosion and blistering

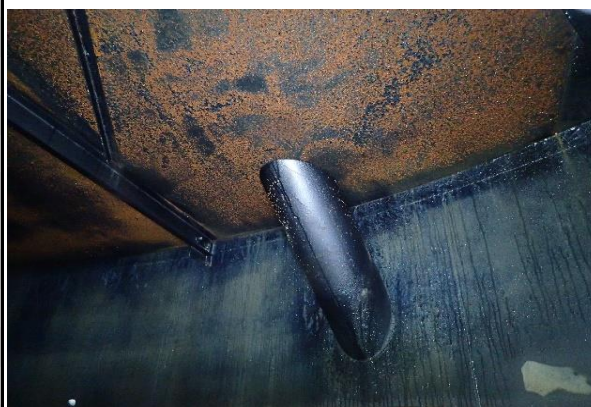
OVERFLOW

Coating				
Satisfactory	Y	<input checked="" type="checkbox"/>	N	<input type="checkbox"/>
Blistering	Y	<input type="checkbox"/>	N	<input checked="" type="checkbox"/>
Cracking	Y	<input type="checkbox"/>	N	<input checked="" type="checkbox"/>
Peeling	Y	<input type="checkbox"/>	N	<input checked="" type="checkbox"/>
Holidays	Y	<input type="checkbox"/>	N	<input checked="" type="checkbox"/>
Pitting	Y	<input type="checkbox"/>	N	<input checked="" type="checkbox"/>
Corrosion	%	Y <input type="checkbox"/>	N	<input checked="" type="checkbox"/>
Seams/Welds	Good			
Conclusion/Discrepancies:				
pipe and welds are in good condition

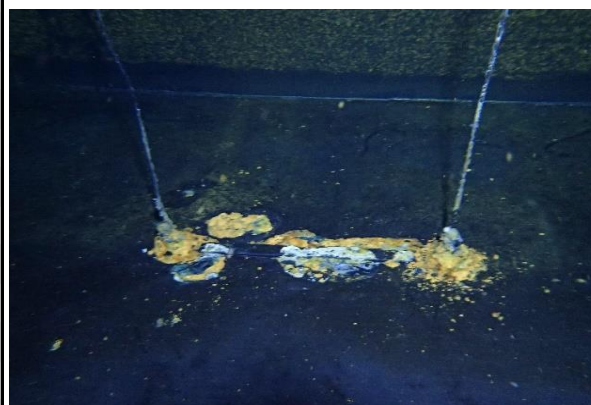
MANUAL LEVEL INDICATOR

Float	Y	<input checked="" type="checkbox"/>	N	<input type="checkbox"/>
Guide Wires	Y	<input checked="" type="checkbox"/>	N	<input type="checkbox"/>
Guide Wire Anchors	Y	<input checked="" type="checkbox"/>	N	<input type="checkbox"/>
Cable / Hardware	Y	<input checked="" type="checkbox"/>	N	<input type="checkbox"/>
Corrosion	15%	Y <input checked="" type="checkbox"/>	N	<input type="checkbox"/>
Operation	Y	<input checked="" type="checkbox"/>	N	<input type="checkbox"/>
Conclusion/Discrepancies:				
Corrosion on the guide wire anchors, system is in working condition, float has some water on the interior and is losing buoyancy

- 5 The float for the level indicator system needs to be replaced. The float has water inside and is losing buoyancy.

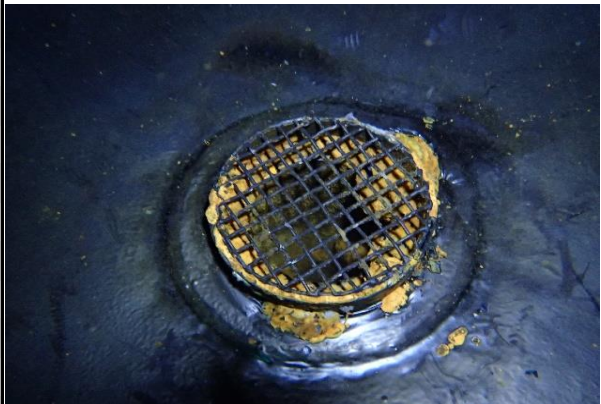
Satisfactory	Y	<input type="checkbox"/>	N	<input checked="" type="checkbox"/>
Blistering	Y	<input type="checkbox"/>	N	<input checked="" type="checkbox"/>
Cracking	Y	<input type="checkbox"/>	N	<input checked="" type="checkbox"/>
Peeling	Y	<input type="checkbox"/>	N	<input checked="" type="checkbox"/>
Holidays	Y	<input type="checkbox"/>	N	<input checked="" type="checkbox"/>
Pitting	Y	<input type="checkbox"/>	N	<input checked="" type="checkbox"/>
Corrosion	15% Y	<input checked="" type="checkbox"/>	N	<input type="checkbox"/>

Seams/Welds Fair

Conclusion/Discrepancies: Corrosion around the weld seam and on the interior of the pipe

- 4 The interior coating on the floor, shell, and roof, in addition to all the appurtenances need to be sandblasted and recoated as the coating has exceeded its useful service life. Blisters, and corrosion are present with some bare steel exposed as well. Sandblast and recoat the interior in the immediate future.

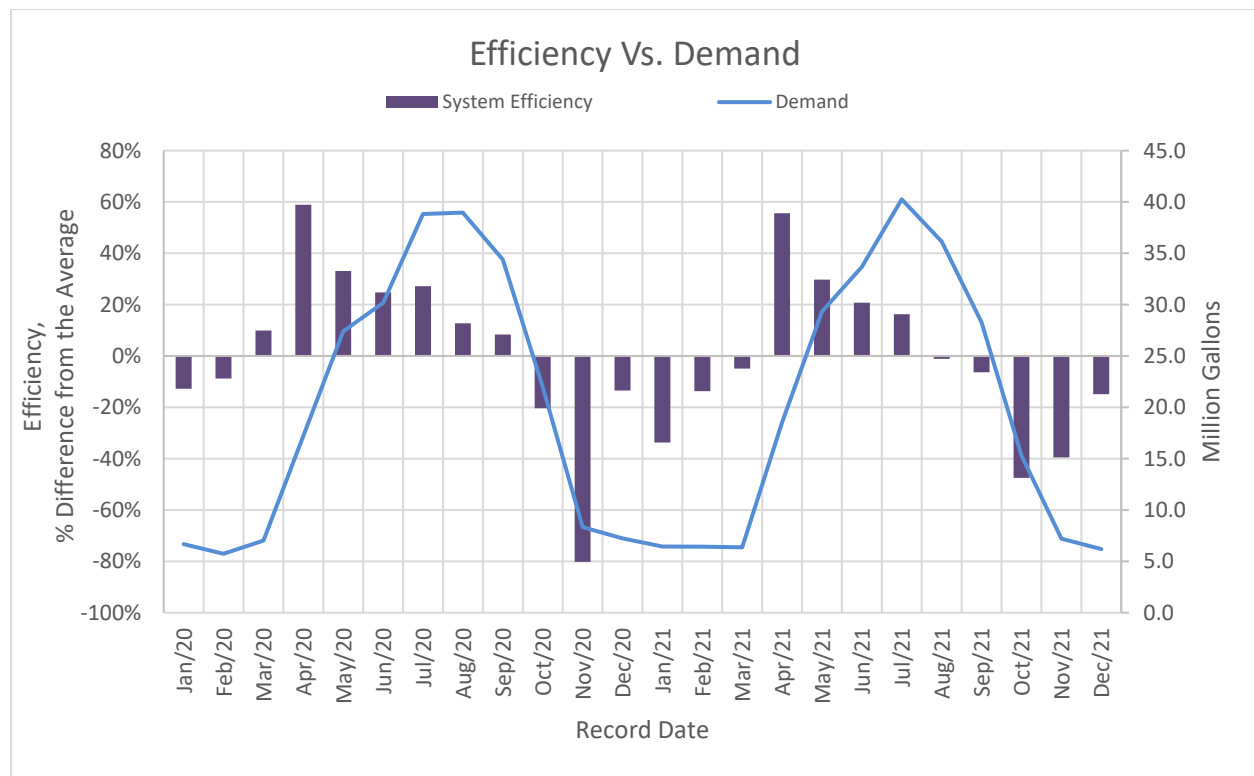
Figure 1: Efficiency Trends

- The y-axis is the % difference from the average efficiency of 2,634 kWhr/MG.
- Positive percentages represent improved efficiency.

Lake Shastina has seasonal trends for water use as seen above in Figure 1; generally these seasons are between the summer months of April and October, and the winter months between November and March. The influx of residents during the warmer months and an increased use for irrigation creates a high demand on LSCSD’s water distribution system. The system observes a broad range of demands, and this results in a wide range of efficiencies. Figure 1 illustrates the seasonal trend and compares this with efficiency values (efficiency on the y-axis is the percent difference from the yearly average of 2,634 Kilowatt hour per million gallons [kWhr/MG], positive numbers reflect improved efficiency). A correlation between the two graphs can be seen; as demand increases so does efficiency, but as demand decreases, efficiency declines.

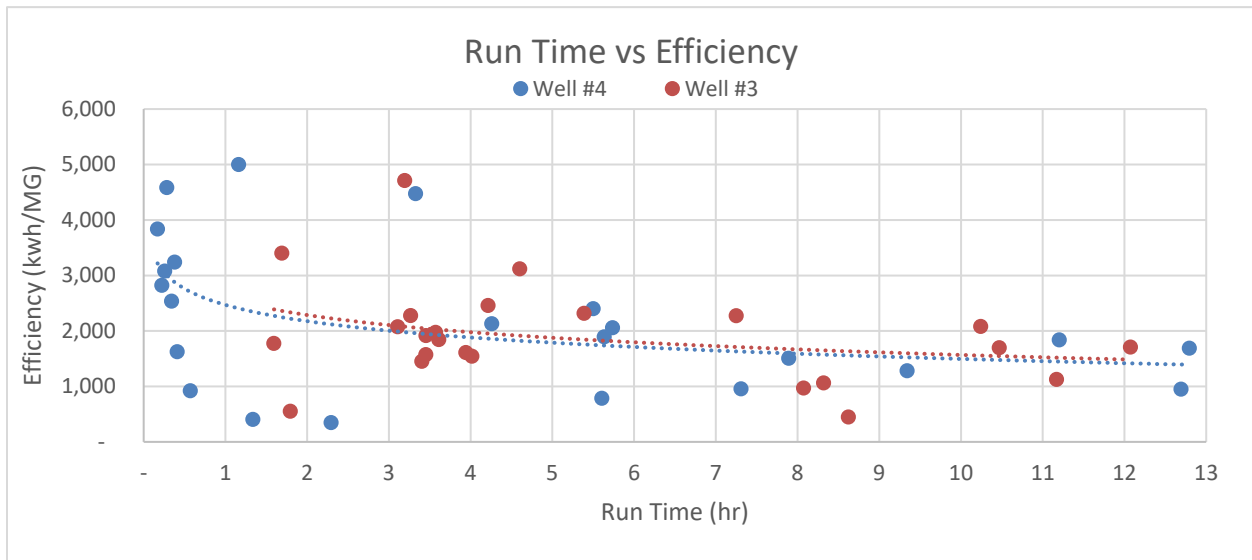
Figure 2: Daily Run Time vs Efficiency (kWhr/MG)

Figure 2 shows a correlation between efficiency and operational run time of Well Pumps 3 and 4. Run time is a measure of how long a pump is operational per day and does not account for the number of cycles per day. As the chart moves from left to right, run time increases and the wire to water ratio also improves. Additionally, the number of points to the left of the chart indicate that there are many instances a pump runs for a short duration.

- "Run time" is a measure of how long a pump is operational per day and does not account for the number of cycles.

SHN recommends the integration of Variable Frequency Drives (VFDs). This energy management device improves efficiency, performance, and reliability of the system. Our findings from the analysis suggest that the well pumps are oversized during the winter months and would benefit from the features of a VFD. A VFD will reduce the frequency of the motor, thus reducing the speed and ultimately the discharge of the pump. By reducing the frequency of the motor, significant energy savings are achievable.

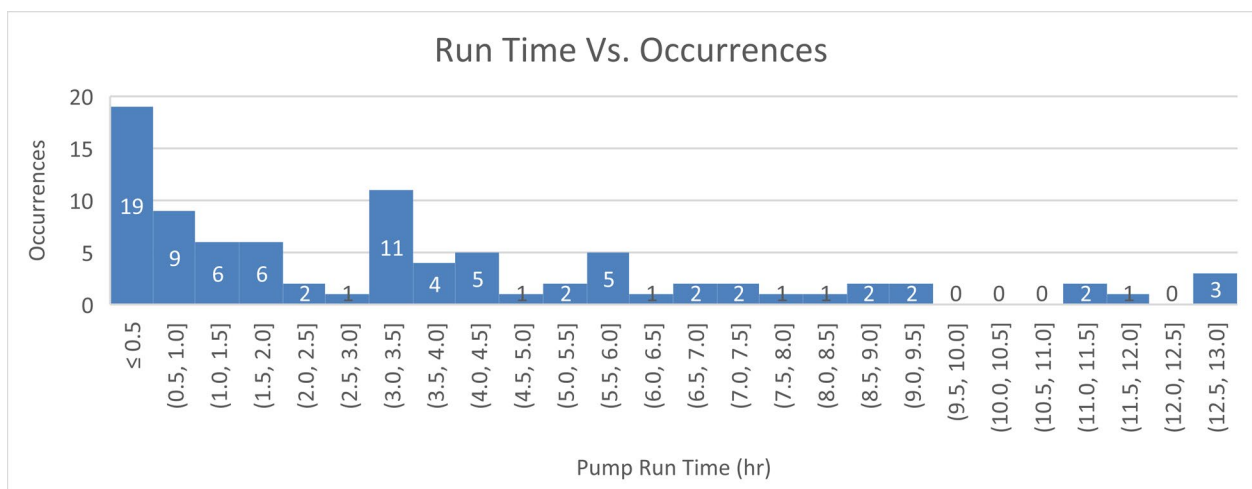
Figure 3: Daily Total Run Time Distribution.

Figure 3 displays a distribution of daily total run times. Run times of less than 1.5 hours account for 40% of occurrences. These short durations are found to be inefficient and are considered a key factor of the inefficiencies in the system.

The combination of lower demand and short cycles is a large contributor to the inefficiencies found within the system. Finding ways to decrease cycles of a pump and stay within the most efficient range will ultimately improve energy efficiency.
